Engineer's Report

Feather River West Levee Phase I ULDC
Compliance

Station 512+00 to 1674+37 and Station 1769+31
to 2368+26

Sutter Butte Flood Control Agency

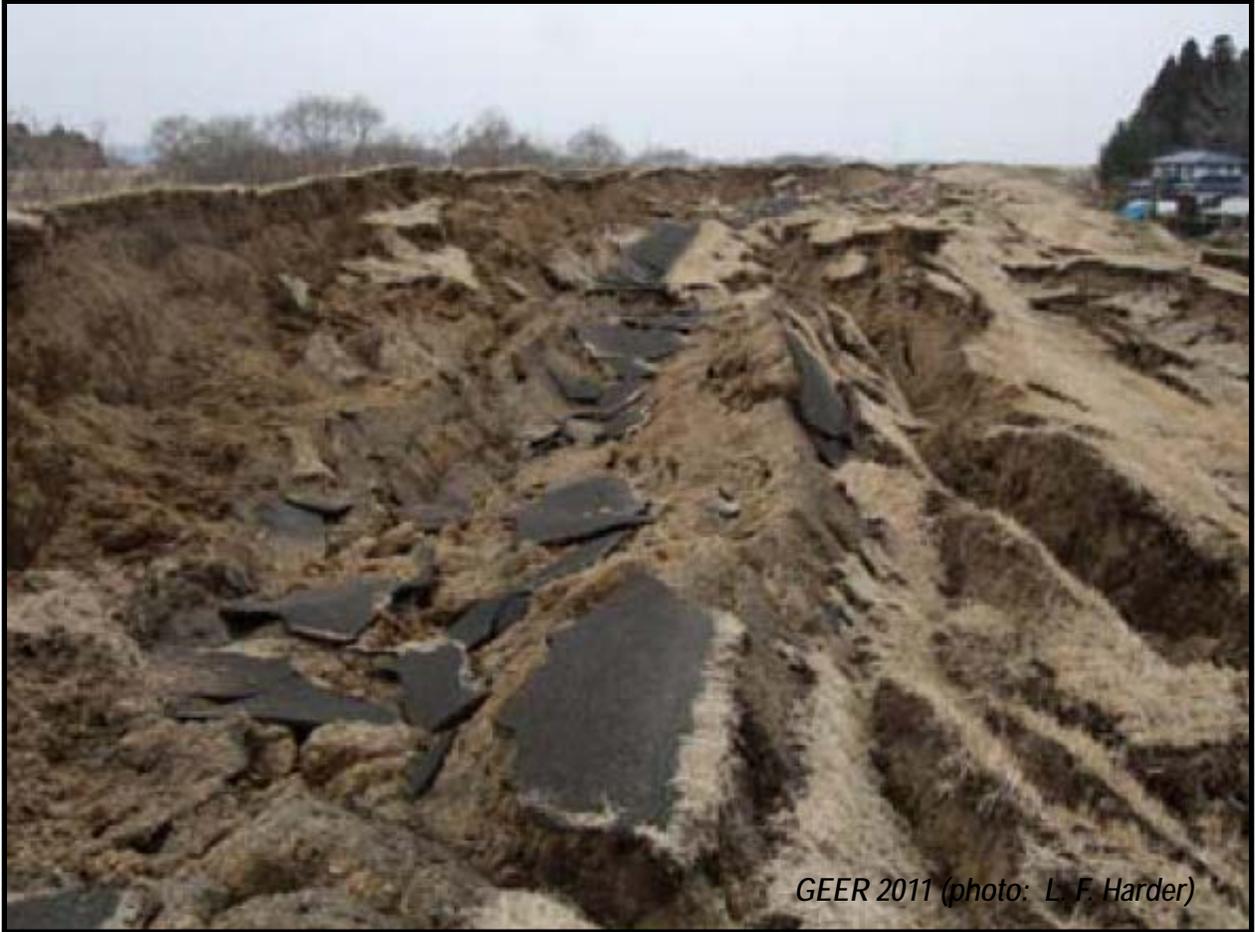
The flow slide was caused by liquefaction of foundation sediments following very strong shaking, estimated to have a PGA between approximately 0.3g and 0.7g, and over 2 minutes of strong shaking – a very extreme loading. Figure 6 presents a photograph of a collapsed segment on the landside slope of the Naruse Left River Levee. Landside groundwater levels were generally higher than those beneath the waterside slopes due to Japanese farming and irrigation practices near the levee on the landside.

Figure 6: Photograph of Collapsed Naruse River Levee Due to a Landside Flow Slide Resulting from Foundation Liquefaction Following the 2011 Magnitude 9 Tohoku Earthquake (from MLIT, 2011)

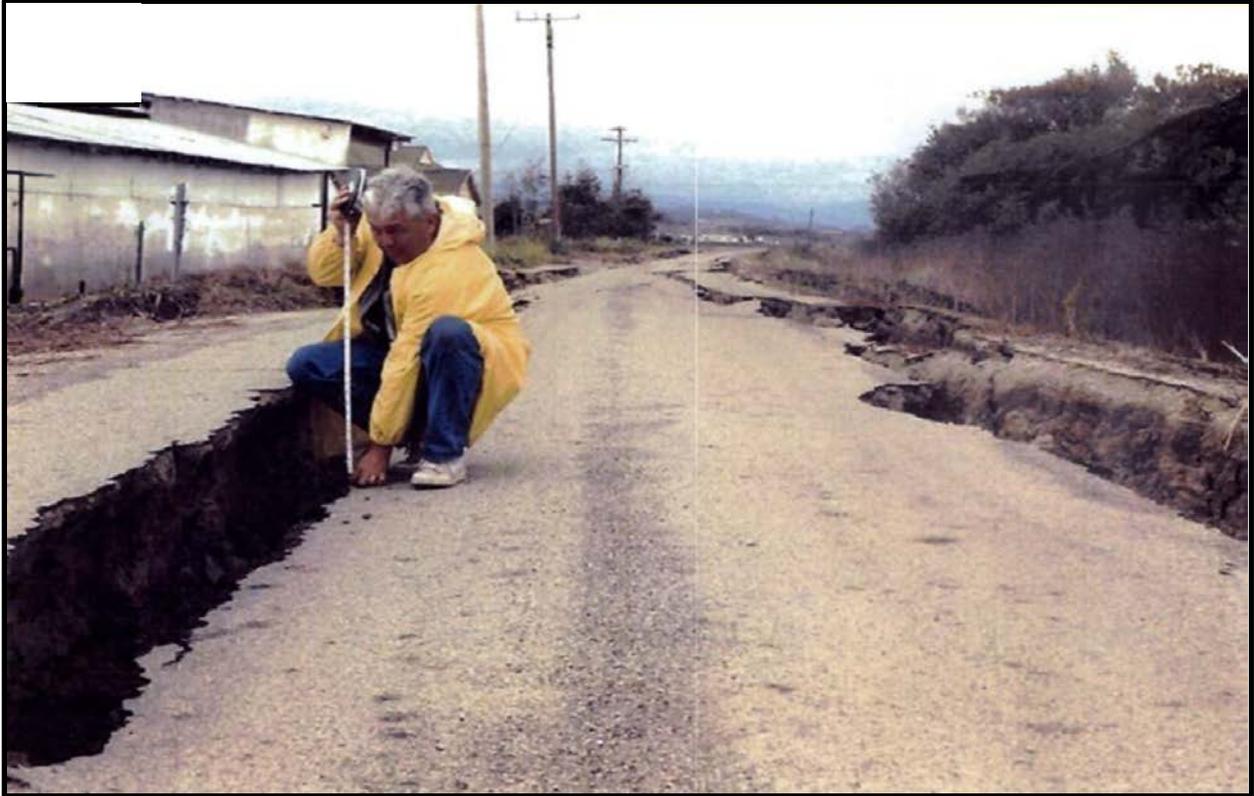
Figure 8 presents a photograph of severe damage to the Pajaro River Levee following the 1989 Magnitude 7.1 Loma Prieta Earthquake. Along the Pajaro River levee, there was extensive liquefaction noted in the free field beyond the levee toe in the form of sand boils, and the approximate 6-foot-high levee experienced longitudinal cracking along the levee crown for much of its length. The relatively small levee is close to the steep river channel, with waterside berm widths ranging from 0 to 90 feet. In the area of the most serious damage, approximately 1,000 feet in length, as depicted in Figure 8, the levee spread laterally towards the river channel by approximately 2 feet, and a graben formed in the levee crown. In this most seriously damaged segment of the levee, the dropped block of the graben was up to approximately 1 foot below the adjacent portions of the levee, and the longitudinal cracks along the edges of the graben were up to 18 inches in width and up to 8 feet in depth (Miller and Roycroft, 2004; Perlea et al., 2013). Peak ground accelerations at the ground surface were estimated to be approximately 0.33g.

Figure 8: Photograph of Pajaro River Levee Crown Damaged by Foundation Liquefaction during the 1989 Magnitude 7.1 Loma Prieta Earthquake (from Perlea et al., 2013)

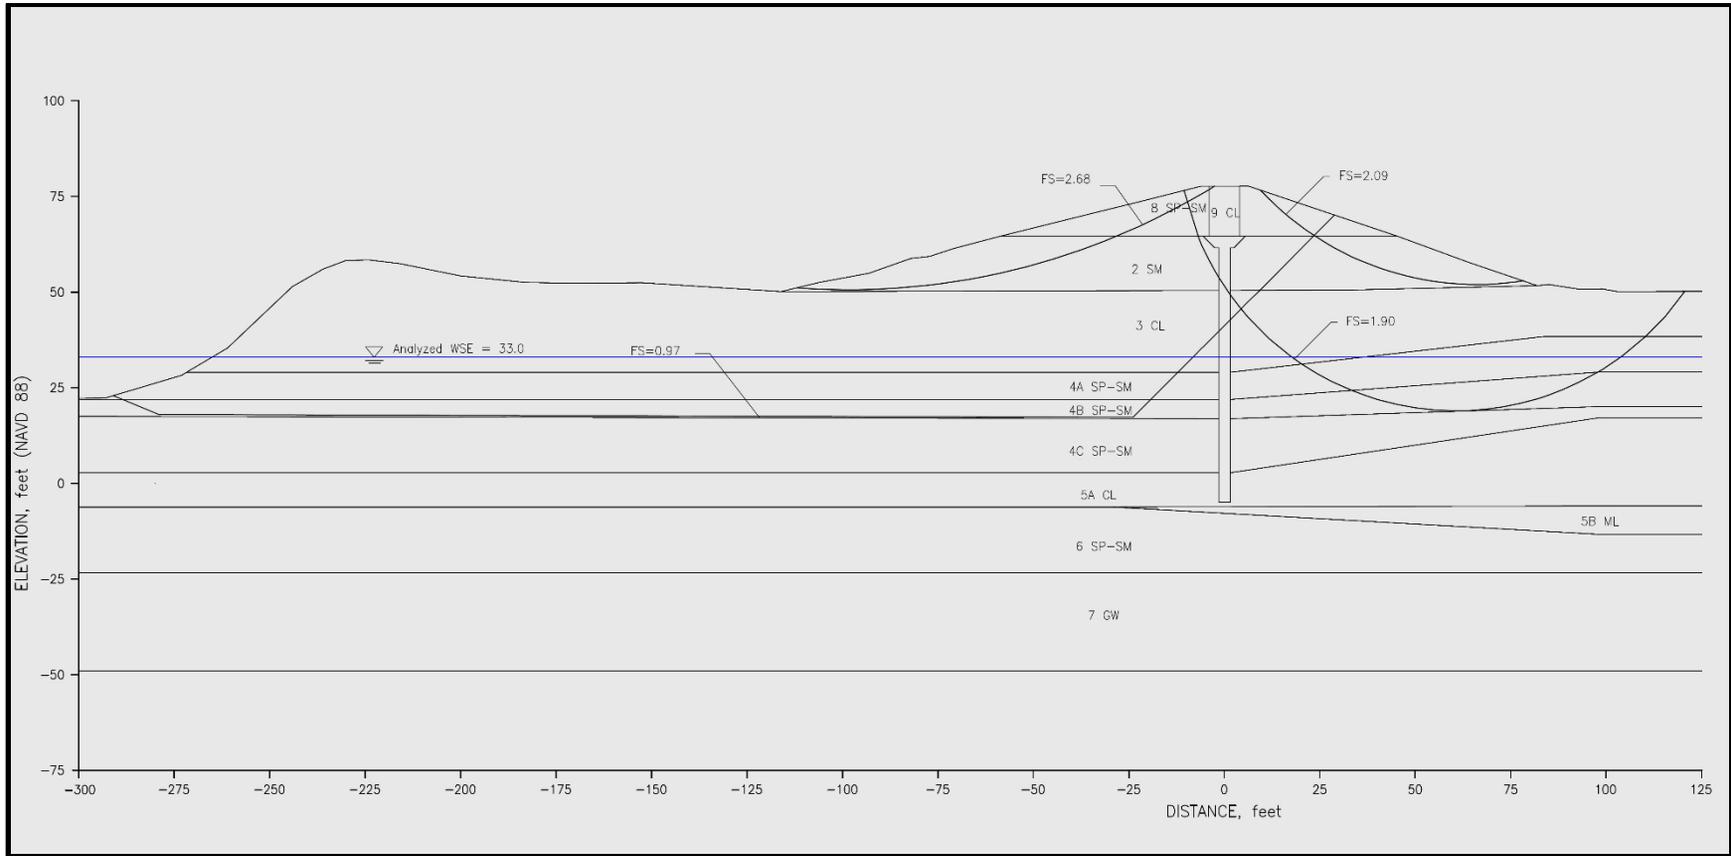
Figure 9: Post Earthquake Slope Stability Analysis Results for Reach 10 of the Feather River West Levee at Station 733+84 – Minimum Post-Earthquake Factor of Safety = 0.97 (from URS, 2012)

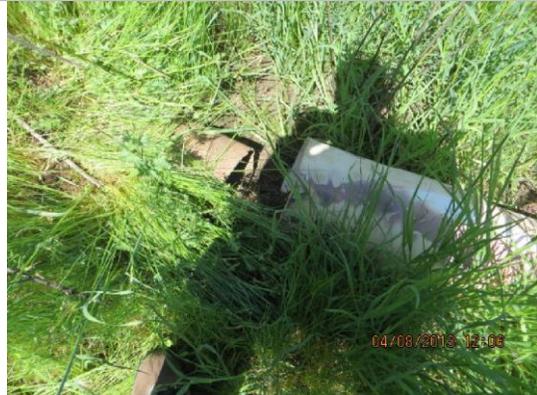
Photo 1 of 3 : UCIP_FA_2020_11383_18782.jpg

WS- 8-inch steel pipe and disconnected pvc pipe on levee slope

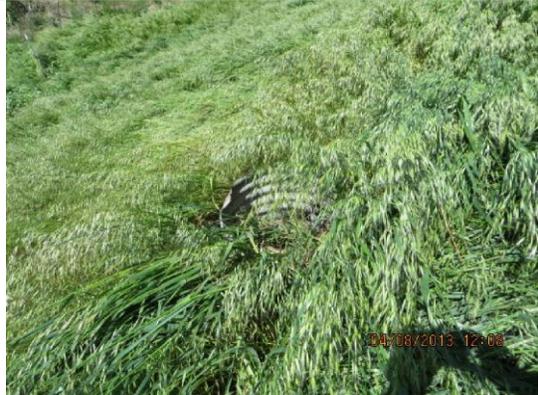
Photo 3 of 3 : UCIP_FA_2020_11383_18780.jpg

LS- CMP riser on levee slope with dense vegetation.

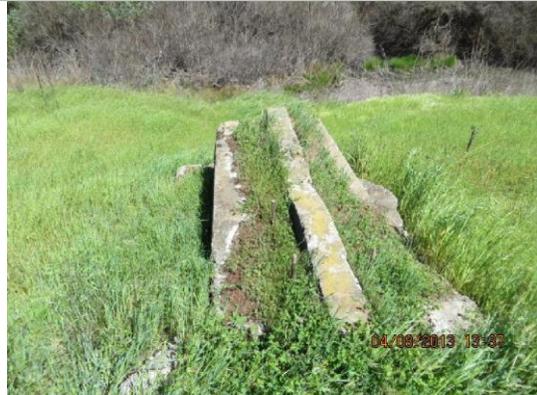
Photo 1 of 3 : UCIP_FA_2020_41348_18882.jpg

WS- abandoned concrete structure on levee slope

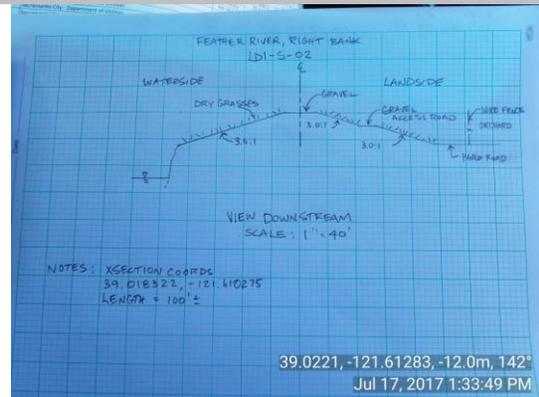
Photo 3 of 3 : LEVAL_FA_2020_145_1769.jpg

The erosion site is planned for PL 84-99 Repair in 2020.

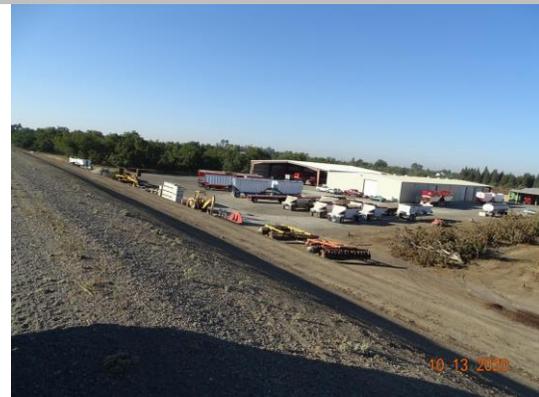
Photo 1 of 1 : FA_2020_LD0001S_433_16_20201019_00041.jpg

View of farm equipment parked in the easement along landside toe, Fall 2020.

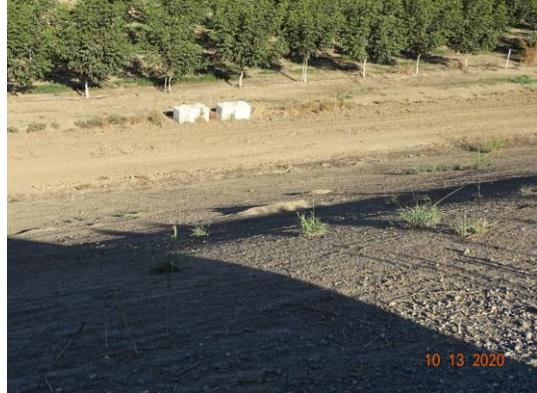
Photo 1 of 1 : FA_2020_LD0001S_433_17_20201019_00043.jpg

View of rodent holes on land side slope, Fall 2020.

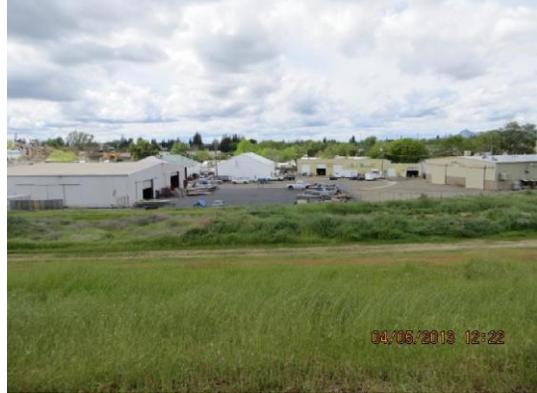
Photo 3 of 3 : UCIP_FA_2020_41887_19569.jpg

LS- overview. No sign post or indicator found.

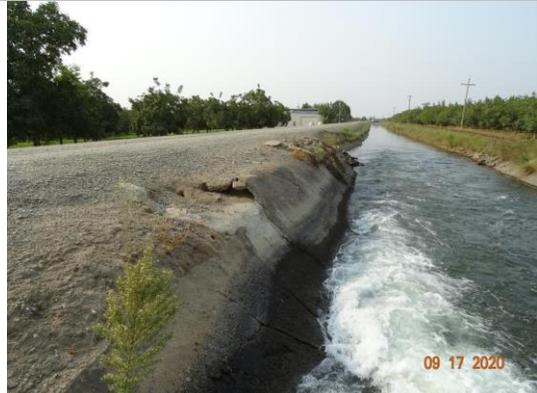
Photo 1 of 1 : FA_2020_MA0007_200_68_20200929_00082.jpg

View of repair to the erosion site on landside ditch, Fall 2020.

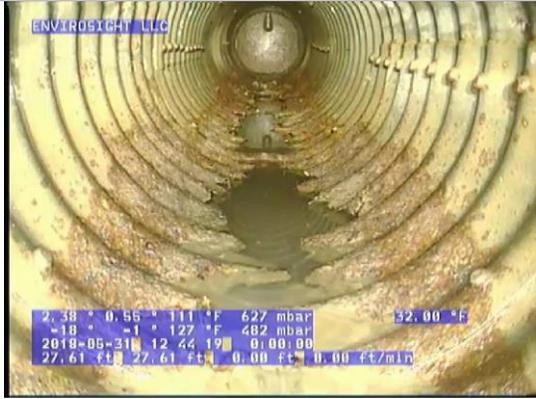
Photo 1 of 3 : UCIP_FA_2020_58340_79201.jpg

LS view: Internal view of pipe condition during DMP Phase 1 Inspection.

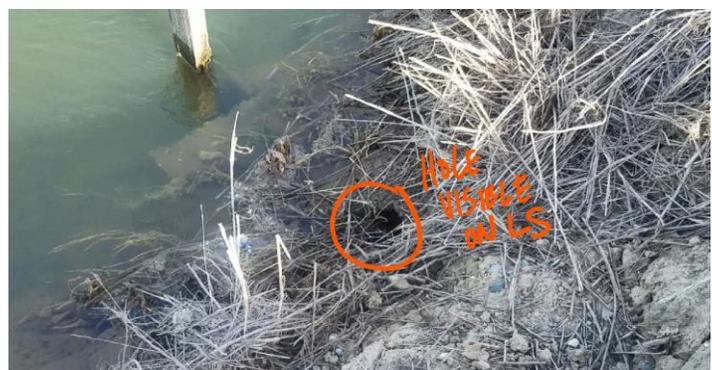
Photo 3 of 3 : UCIP_FA_2020_58340_79229.jpg

LS view: hole visible on LS, appears to be linked to burrow hole that is allowing flow to go into pipe.

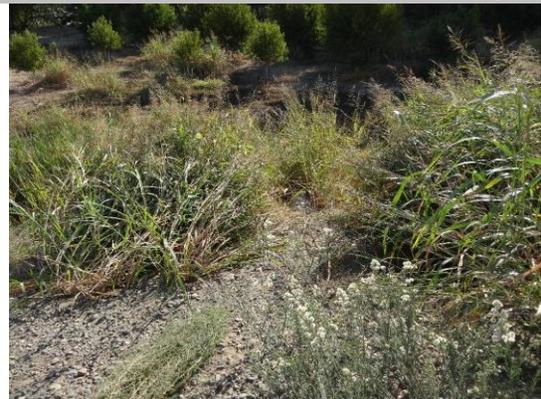
Photo 3 of 3 : UCIP_FA_2020_57380_77332.jpg

WS view: dense vegetation along WS slope.
