# Technical Memorandum

**Project** Feather River West Levee

**Subject** Geotechnical Considerations for Landside Slopes of Segments 1 to 6  
for the Feather River West Levee Project

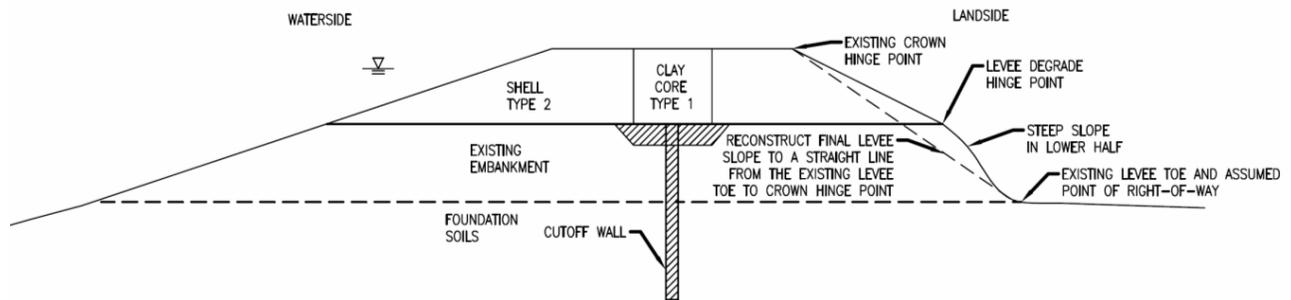
2. In some areas, there are slopes that have localized steeper portions in either the upper or lower portion of the slope (Figure 1 and Figure 2). That is, the slopes have a slightly concave or convex profile. The current proposal of only re-grading the portion of the slope above the degrade elevation would leave many of these localized steeper portions in place. These slopes have the potential for localized stability problems during construction and in the longer term.

*Figure 1: Levee Section with Steep Slope in Lower Half of the Levee*

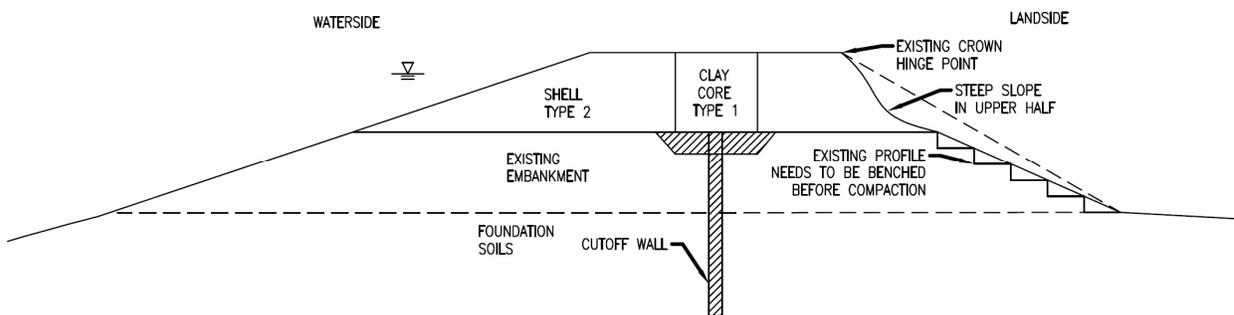
*Figure 2: Levee Section with Steep Slope in Upper Half of the Levee*

In levee sections with a steep slope in the upper half of the levee (steeper than 2H:1V), the URS team recommends that the currently proposed approach is changed so that during levee reconstruction the whole levee slope is re-graded to a straight line starting from the existing levee toe to the new levee crown hinge point. This procedure would require benching in the existing lower half of the slope to provide key-in to the existing slope. Figure 2 is a schematic drawing of the proposed slope re-grade for a levee section with a steep slope in the upper half of the levee.
