Engineer's Report

Feather River West Levee Phase I ULDC
Compliance

Station 512+00 to 1674+37 and Station 1769+31
to 2368+26

Sutter Butte Flood Control Agency

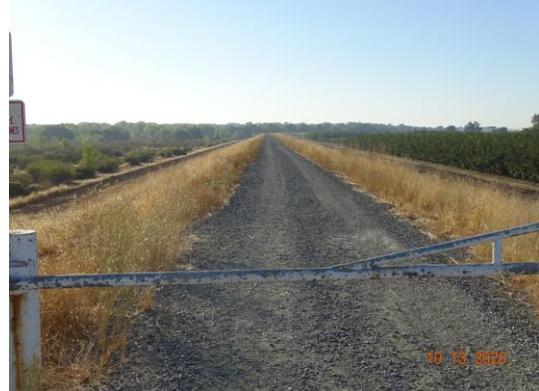
Photo 1 of 1 : FA_2020_LD0001S_433_15_20201019_00042.jpg

LM Start	0.00	Rating **	A/W	Issue No.	15
LM End	4.34	Issue Type +	Ma	Location *	CR
Category	Earthen Levee		GPS Latitude/Longitude		
			Start	End	
Item	Crown Surface / Depressions / Rutting		38.950976 °	39.010657 °	
			-121.585753 °	-121.602887 °	
DWR ID	DWR_LD0001S_01_s_2020_15				
Comment Code					
C1 : Add appropriate material and re-grade the levee to bring the crown above the design elevation.					
Inspector Comment					
USACE Project completed, O&M manual and levee have not been turned over to LMA. This section is not maintained yet, Fall 2020.

View looking downstream of completed construction, but levee has not been turned over to LMA, Fall 2020.

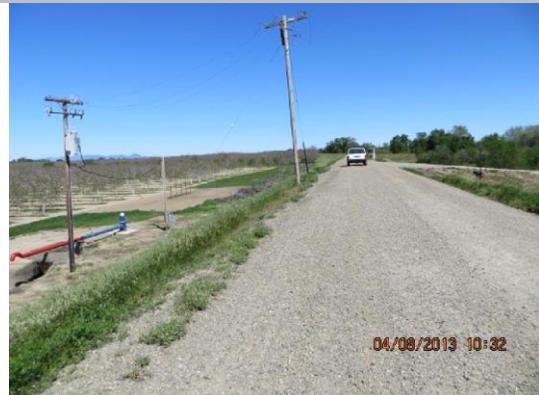
Photo 1 of 3 : UCIP_FA_2020_41624_18769.jpg

Comment Code					
Inspector Comment					
DS_ID:18653 FS_ID:41624 EP_NO: 4667 Repair Type: Non-Urgent EVAL Issue: Crossing Status: Found UCIP Comments: 04/12/2013 Abandoned crossing. Concrete box on both sides found. Pipe remainings are found on WS. (DWR UCIP - P. Amatya) FIELD_STRUCT_DESC: *ABANDONED* 36-inch steel irrigation pipe through the levee, 10 feet below the crown. Concrete box found on each side. Pipe remains found on the waterside (WS) after the removal of 40 feet of 36-inch steel pipe from a spur levee and 20 feet of 36-inch steel pipe from the landside (LS) slope of the Feather River Levee. (Plans for removal of a portion and filling with concrete a portion of an abandoned 36-inch steel pipe through the levee authorized under Permit No. 4667, 1964 - Levee District No. 1 of Sutter County [LD0001S]). [Additional Reference(s): USACE Sacramento O&M Manual 144, August 1955, (Station 735+57)]. FS Date: 4/12/2013

Crown view- overview of both sides of the levee

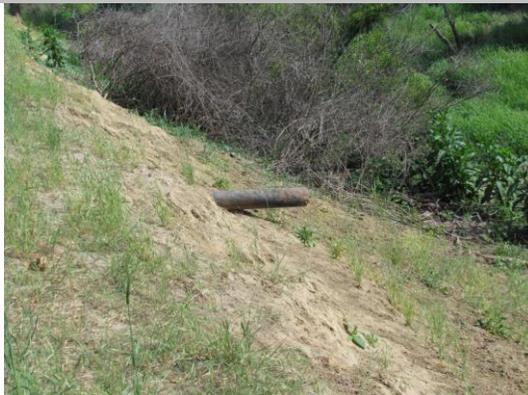
Photo 1 of 3 : UCIP_FA_2020_53068_75107.jpg

Comment Code					
Inspector Comment					
<p>DS_ID:17917 FS_ID:53068 EP_NO: N/A Repair Type: Non-Urgent EVAL Issue: Crossing Status: Not Found UCIP Comments: 10/15/2018 Pipe not found. Pipe removed as part of the Project Area A Feather River West Levee Project. Contacted LMA to obtain as-built drawings showing the pipe removal through the levee. Crossing has been downgraded from Urgent to Non-Urgent, waiting to receive as-built drawings pertaining to levee improvement project for this section of the levee. (O. Magana - DWR UCIP)07/20/2016 Same as previous comment, although pipe is open on the waterside (WS) and capped on the LS. Note that this section of levee will likely be reconstructed as part of Project Area A of the Feather River West Levee Project (Star Bend to Sutter Bypass). (K. Fazel - UCIP)05/23/2016 Needs proper abandonment; pipe open on both ends (courtesy of Sterling York, DWR Inspector). (K. Fazel - UCIP) FIELD_STRUCT_DESC: *REMOVED* 8-inch steel pipe of an unknown purpose through the levee, 4.6 feet below the crown. Siphon breaker in a 24-inch corrugated metal pipe (CMP) riser on the landside (LS) shoulder, not found in 2016. [Additional Reference(s): DWR Levee Log, 2005. USACE Sacramento O&M Manual 144, August 1955, (Station 657+00), As-Built Drawing No. 4-4-205-1]. FS Date: 10/16/2018</p>

Pipe visible on WS slope. Photo courtesy of Sterling York, DWR Inspector.

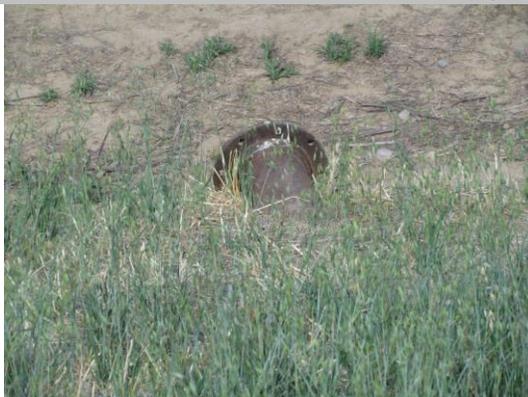
Photo 2 of 3 : UCIP_FA_2020_53068_75108.jpg

Pipe open on LS end. Photo courtesy of Sterling York, DWR Inspector.

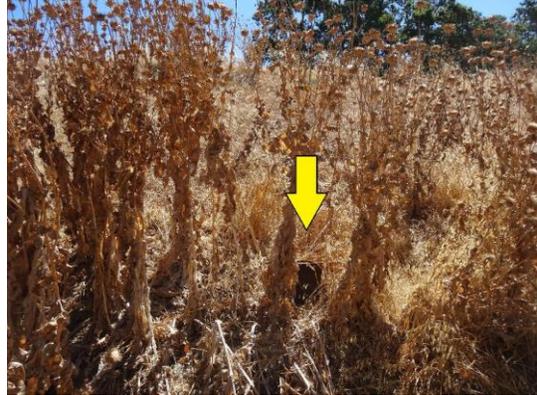
Photo 3 of 3 : UCIP_FA_2020_53068_76120.jpg

LS view: pipe appears to be capped, though in a rudimentary fashion.

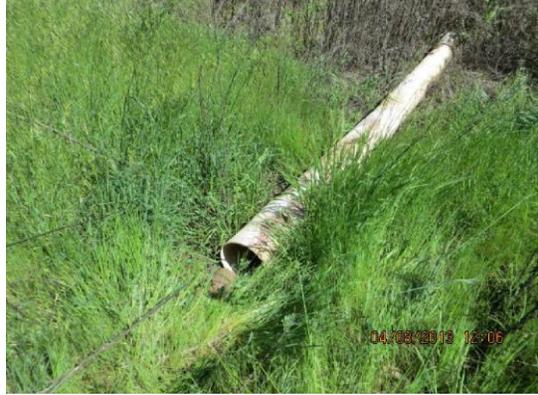
Photo 2 of 3 : UCIP_FA_2020_11383_18781.jpg

WS-a disconnected pvc pipe on levee slope

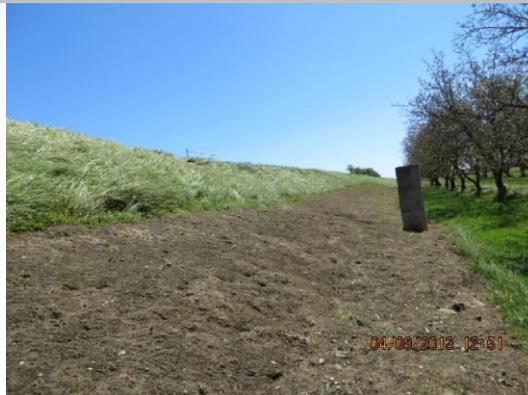
Photo 1 of 3 : UCIP_FA_2020_41787_18793.jpg

Comment Code					
Inspector Comment					
DS_ID:18667 FS_ID:41787 EP_NO: N/A Repair Type: Non-Urgent EVAL Issue: Crossing Status: Found UCIP Comments: 04/12/2013 Pipe appears to be abandoned and should be verified as having been done so properly. - concrete standpipe with 10-inch steel pipe.- concrete wing wall- no pipe-abandoned structure- a pump found on other side of the levee (WS) but not sure whether it is associated with this crossing. (DWR UCIP - P. Amatya) FIELD_STRUCT_DESC: *ABANDONED* 24-inch gravity drainage pipe of an unknown material under the landside (LS) approach, at an unknown depth. Plans to install a 10-inch corrugated iron gravity drainage culvert under the LS approach, at an unknown depth. Crossing not found in the O&M Manual. FS Date: 4/12/2013

LS- overview of landside with concrete standpipe

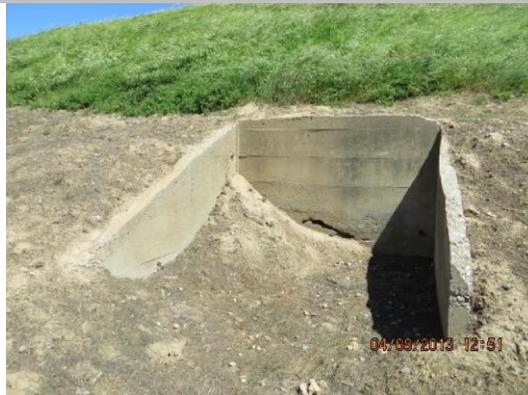
Photo 2 of 3 : UCIP_FA_2020_41787_18792.jpg

LS- abandoned wing wall- no pipe

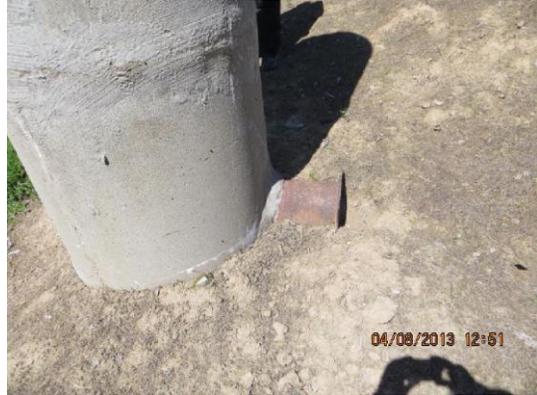
Photo 3 of 3 : UCIP_FA_2020_41787_18791.jpg

LS- concrete standpipe with disconnected steel pipe

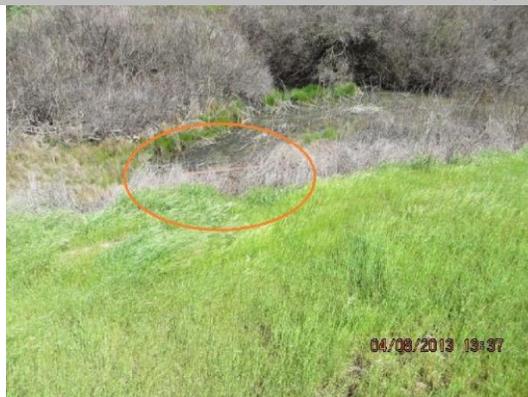
Photo 2 of 3 : UCIP_FA_2020_41348_18881.jpg

WS- abandoned steel structure on waterway

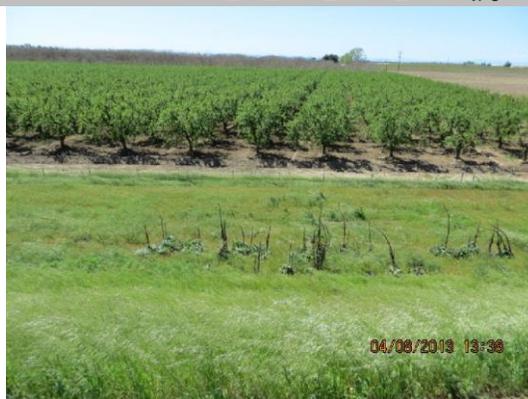
Photo 3 of 3 : UCIP_FA_2020_41348_18880.jpg

Overview of landside of the levee- no pipes visible. Dense vegetation.

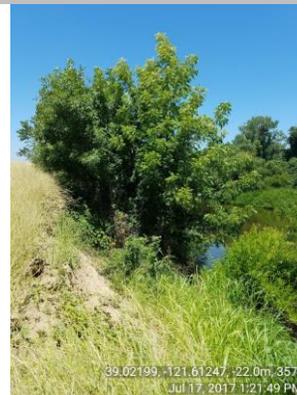
Photo 1 of 3 : LEVAL_FA_2020_145_1767.jpg

LM Start	5.02	Rating **	A/W	Issue No.	25
LM End	5.43	Issue Type +	Ma	Location *	
Category	Supplemental			GPS Latitude/Longitude	
				Start	End
Item	2017 Storm Damage			39.018322 °	39.023753 °
				-121.610275 °	-121.613171 °
DWR ID	LD1-S-02				
Comment Code					
Inspector Comment					
The erosion site is planned for PL 84-99 Repair in 2020. Site ID No:145 Site Designation:LD1-S-02 Rating: Critical

The erosion site is planned for PL 84-99 Repair in 2020.

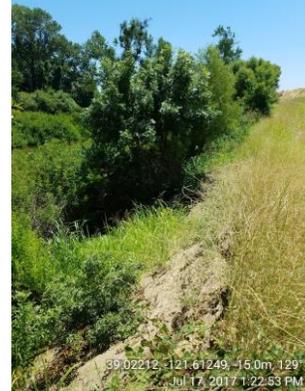
Photo 2 of 3 : LEVAL_FA_2020_145_1768.jpg

The erosion site is planned for PL 84-99 Repair in 2020.

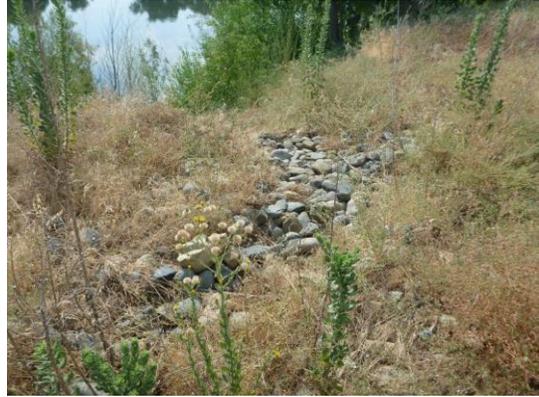
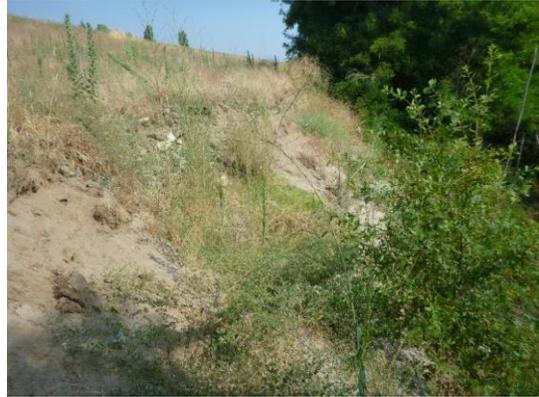
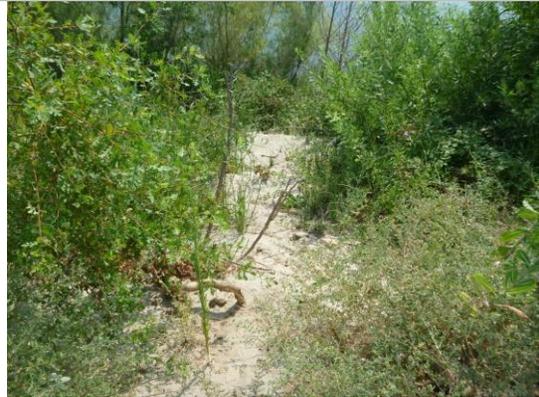
LM Start	7.69	Rating **	A/W	Issue No.	19
LM End	7.74	Issue Type +	Ma	Location *	WS
Category	Earthen Levee		GPS Latitude/Longitude		
			Start	End	
Item	Erosion / Bank Caving		39.055986 °	39.056710 °	
			-121.611301 °	-121.611331 °	
DWR ID	LD1-S-03				
Comment Code					
E1 : Note and monitor erosion site.					
Inspector Comment					
This was a 2017 Storm Damage site for erosion. Site ID No:146 Site Designation:LD1-S-03

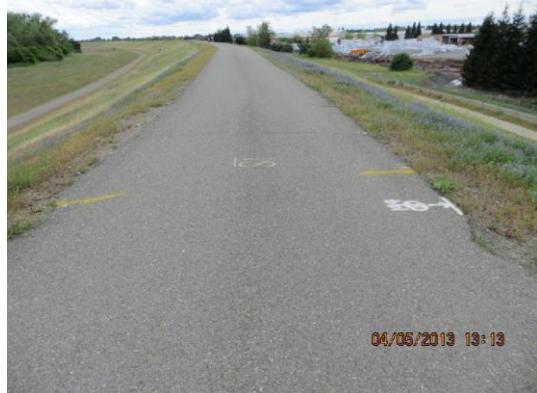
Photo 1 of 3 : UCIP_FA_2020_41841_19538.jpg

LM Start	11.99	Rating **	M	Issue No.	32
LM End	11.99	Issue Type +	En	Location *	
Category	Supplemental		GPS Latitude/Longitude		
			Start	End	
Item	DWR UCIP Field Study		39.114856 °	39.114856 °	
			-121.605821 °	-121.605821 °	
DWR ID	17932				
Comment Code					
Inspector Comment					
DS_ID:17932 FS_ID:41841 EP_NO: N/A Repair Type: Non-Urgent EVAL Issue: Crossing Status: Indicator Found UCIP Comments: 04/05/2013 Need to install Gasline Markers.Fenced control station.Indicator on LS across concrete ditch.Found road markings.(DWR UCIP - P. Amatya) FIELD_STRUCT_DESC: 1 of 2: 16-inch natural gas pipeline of an unknown material through the levee, 3 feet below the crown. PG&E gas line crossing sign on the waterside (WS) shoulder. [Additional Reference(s): DWR Levee Log, 2005]. FS Date: 4/5/2013

Levee Crown: gasoline indicator/markings on crown road.

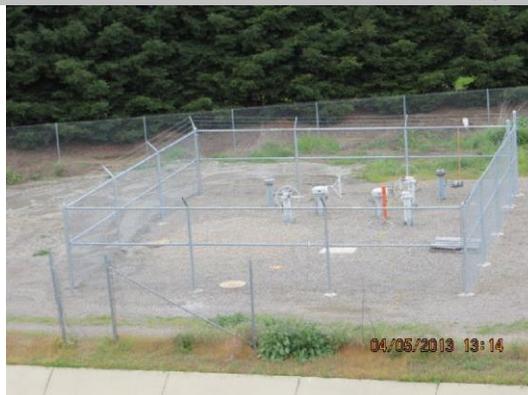
Photo 3 of 3 : UCIP_FA_2020_41889_19564.jpg

LS- fenced control station with gasoline indicator across concrete ditch.

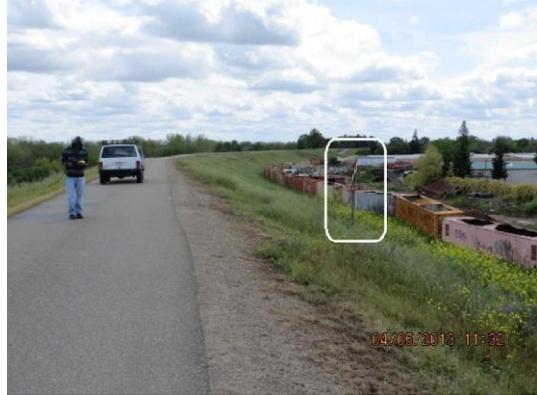
Photo 1 of 2 : UCIP_FA_2020_12092_19624.jpg

DS_ID:17923
 FS_ID:12092
 EP_NO: N/A
 Repair Type: Non-Urgent
 EVAL Issue:
 Crossing Status: Indicator Found
 UCIP Comments: 04/05/2013 Only a gasline indicator found on LS.Needs gasline marker also on WS.(DWR UCIP - P. Amatya)
 FIELD_STRUCT_DESC: 16-inch natural gas pipeline of an unknown material through the levee, 3.5 feet below the crown. Pipeline protected in place as part of the Feather River West Levee Reconstruction Project. Marker installed on the landside (LS). [Additional Reference(s): DWR Levee Log, 2005. Sutter-Butte Flood Control Agency, Volume 3, As-Built Drawing No. C-124, Sheet 62, (Station 1073+41)].
 FS Date: 4/5/2013

LS- overview of gasline marker on levee slope

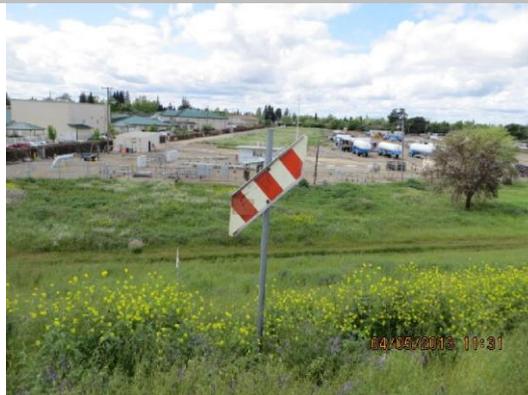
Photo 2 of 2 : UCIP_FA_2020_12092_19623.jpg

LS- gasoline marker on levee slope

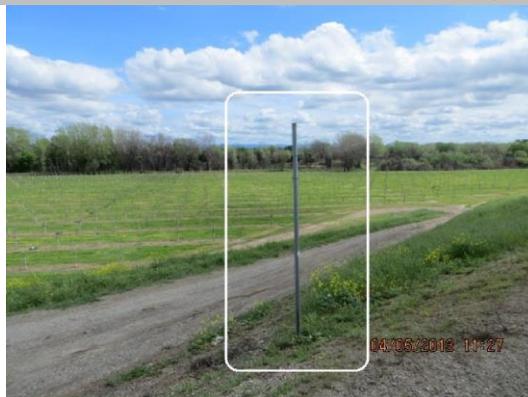
Photo 1 of 3 : UCIP_FA_2020_12104_19642.jpg

WS- needs a gasoline indicator.

Comment Code					
Inspector Comment					
DS_ID:18644 FS_ID:12104 EP_NO: 17259 Repair Type: Non-Urgent EVAL Issue: Crossing Status: Indicator Found UCIP Comments: 04/05/2013 Found an indicator only on LS. Needs an indicator also on WS.(DWR UCIP - P. Amatya) FIELD_STRUCT_DESC: *REMOVED* 8.375-inch-wide electrolysis test station (ETS) at a depth of 4 feet was connected to the existing 8-inch steel natural gas pipeline within the waterside (WS) levee toe. Pipeline has been removed as part of the Feather River West Levee Reconstruction Project. [Additional Reference(s): Sutter-Butte Flood Control Agency, Volume 3, As-Built Drawing No. C-124, Sheet 62, (Station 1079+91), no replacement pipe mentioned]. FS Date: 4/5/2013

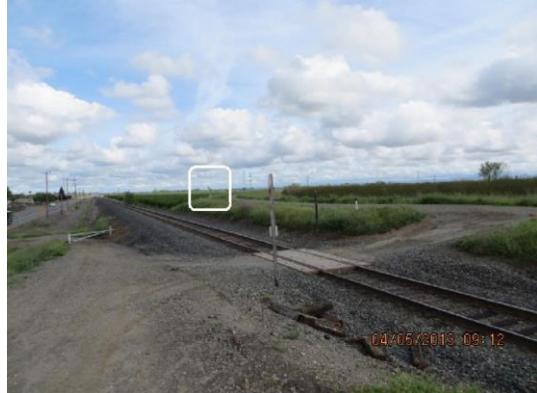
Photo 1 of 2 : UCIP_FA_2020_41888_19709.jpg

LM Start	16.11	Rating **	M	Issue No.	37
LM End	16.11	Issue Type +	En	Location *	
Category	Supplemental		GPS Latitude/Longitude		
			Start	End	
Item	DWR UCIP Field Study		39.168830 °	39.168830 °	
			-121.622628 °	-121.622628 °	
DWR ID	18645				
Comment Code					
Inspector Comment					
DS_ID:18645 FS_ID:41888 EP_NO: 3823 Repair Type: Non-Urgent EVAL Issue: Crossing Status: Indicator Found UCIP Comments: 04/05/2013 Need to contact owner to determine status of crossing and install markers if appropriate. Several lines in area. (DWR UCIP - P. Amatya) FIELD_STRUCT_DESC: 8-inch steel natural gas pipeline through the levee and overflow area, 3.3 feet below the crown. (Plans for installation of a steel pipeline through the levee authorized under Permit No. 3823, 1961 - Southern Pacific Pipe Lines, Inc.). FS Date: 4/5/2013

Railway and levee crossing and gasline sign across the railway

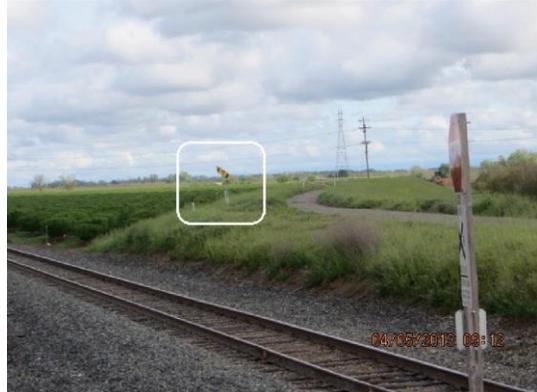
Photo 2 of 2 : UCIP_FA_2020_41888_19708.jpg

Gasline sign across the railway

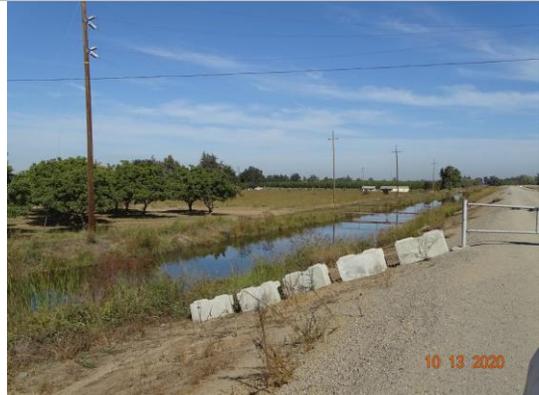
Photo 1 of 1 : FA_2020_LD0009_202_20_20201019_00003.jpg

LM Start	5.66	Rating **	M	Issue No.	20
LM End	6.00	Issue Type +	En	Location *	LS
Category	Earthen Levee		GPS Latitude/Longitude		
			Start	End	
Item	Encroachments		39.247349 °	39.252258 °	
			-121.637341 °	-121.637077 °	
DWR ID	DWR_LD0009_01_f_2016_20				
Comment Code					
DT : Ditch					
Inspector Comment					
A ditch is located at the toe of the levee on the landside.

View looking upstream of ditch at the toe of the levee on the landside, Fall 2020.

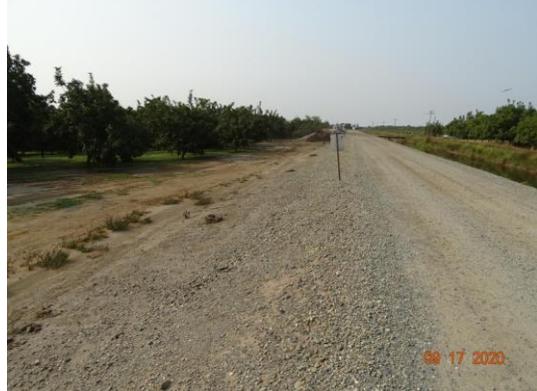
Photo 1 of 1 : FA_2020_MA0007_200_69_20200929_00080.jpg

LM Start	0.31	Rating **	N	Issue No.	69
LM End	0.37	Issue Type +	Ma	Location *	WS
Category	Earthen Levee		GPS Latitude/Longitude		
			Start	End	
Item	Trim / Thin Trees		39.314991 °	39.315693 °	
			-121.635038 °	-121.634459 °	
DWR ID	DWR_MA0007_01_s_2016_69				
Comment Code					
T5 : Tree stumps.					
Inspector Comment					
Several tree stumps at WS levee toe.

View looking downstream at several tree stumps on the waterside levee toe.

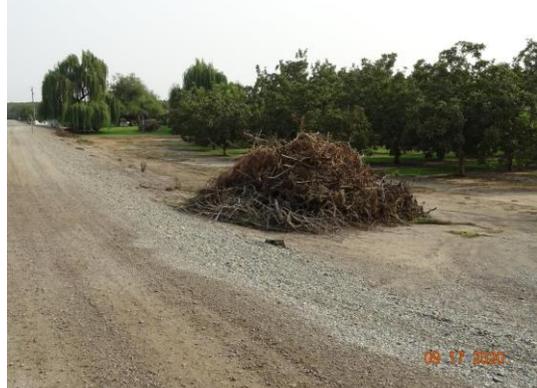
Photo 1 of 1 : FA_2020_MA0007_200_32_20200929_00081.jpg

LM Start	0.32	Rating **	M	Issue No.	32
LM End	0.32	Issue Type +	En	Location *	WS
Category	Earthen Levee		GPS Latitude/Longitude		
			Start	End	
Item	Encroachments		39.315020 °	39.315020 °	
			-121.635017 °	-121.635017 °	
DWR ID	DWR_MA0007_01_f_2020_32				
Comment Code					
DE : Debris					
Inspector Comment					
Large debris pile on water side levee toe needs to be removed, Fall 2020.

View of debris pile on waterside levee toe, Fall 2020.

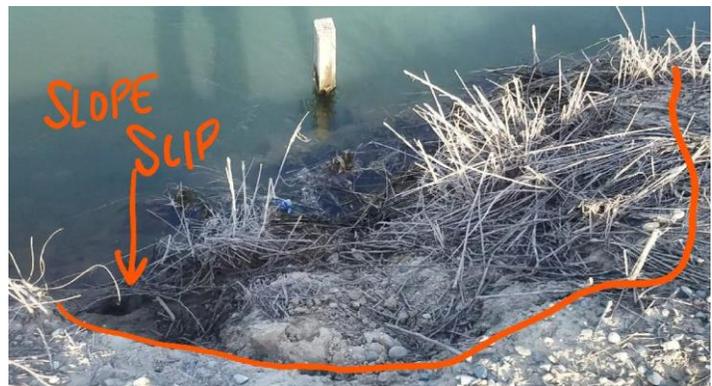
Photo 2 of 3 : UCIP_FA_2020_58340_79230.jpg

DS_ID:16928
 FS_ID:58340
 EP_NO: N/A
 Repair Type: Urgent
 EVAL Issue: Pipe Integrity
 Crossing Status: Found
 UCIP Comments: 09/04/2019 Photos provided by M. Bellomy with Flood Maintenance Office have been uploaded to record. Photos highlight the extent of damage on LS slope. (O. Magana - DWR UCIP)05/08/2019 LMA Supervisor, Shawn Freitag, has completed a temporary repair to prevent water from flowing from LS irrigation ditch to WS. Burrow hole on LS has been plugged and concrete bags have been placed to prevent water from entering the pipe and causing further damage to the pipe section through levee. Crossing will continued to be monitored by LMA. Need to coordinate with DWR DMP to address permanent solution for abandoned crossing. (O. Magana - DWR UCIP)

05/07/2019 Record has been updated from Non-Urgent to Urgent due to pipe integrity issues found. DWR UCIP was notified by LMA Supervisor, Shawn Freitag, of pipe leak observed on LS and causing flooding to WS. Burrow hole is allowing flow to enter pipe. Hole present on pipe section near the concrete headwall. Erosion (sloughing) observed on LS slope. Pipe section tied to WS concrete box that runs parallel to levee was flooding Kiwi Orchard. Section of concrete distribution box was removed to allow for proper drainage and prevent flooding to Kiwi Orchard. Measures by LMA Supervisor are being pursued to stop flow through pipe to prevent further erosion damage through the levee (damage identified during DWR DMP Phase 1 internal video inspection). Record has been updated to reflect the DMP Phase 1 inspection report, crossing has been upgraded from Non-Urgent to Urgent based on the condition of the pipe through the levee. (O. Magana - DWR UCIP)12/07/2018 Encroachment owner information: Sukhraj Singh Pamma, 9850 Sheldon Avenue, Live Oak, CA 95953-9784, 1-530-695-2490. The CVFPB sent an encroachment violation notice on August 16, 2011 to Mr. and Ms. Ratana. Information obtained from the Levee_Encroachment_listing_11288.pdf which was received from SBFCA. Need to coordinate with CVFPB to determine status of permit. (O. Magana - DWR UCIP)

LS view: section of levee has slipped at pipe crossing.

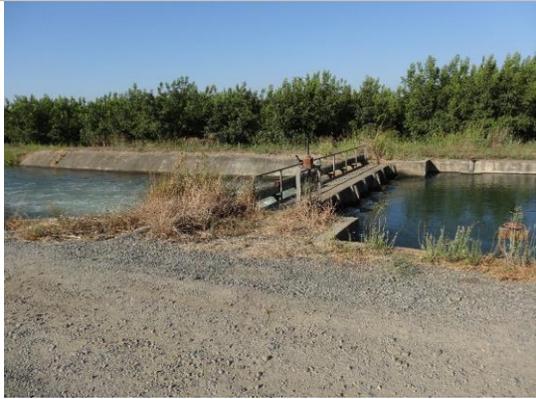
Photo 1 of 3 : UCIP_FA_2020_57380_77330.jpg

DS_ID:20816
 FS_ID:57380
 EP_NO: 11987
 Repair Type: Non-Urgent
 EVAL Issue: Unauthorized Modification or Non-Compliant Permit
 Crossing Status: Found
 UCIP Comments: 05/07/2019 Crossing has been modified. Need to contact owner to determine permit authorizing new modifications on both WS and LS. (O. Magana - DWR UCIP)12/07/2018 New encroachment owner information: Sukhraj Singh Pamma, 9850 Sheldon Avenue, Live Oak, CA 95953-9784, 1-530-695-2490. Information obtained from the Levee_Encroachment_listing_11288.pdf received from SBFCA. The permit listed in the pdf file is 11987. This permit was issued to the Cox Brothers in 1977. Need to have new owner apply for Permit Name Change with the CVFPB. (O. Magana - DWR UCIP) 08/09/2017 It appears that this pipe is used to water the orchard located on the WS. Dense vegetation present along the WS slope, recommend clearing vegetation to allow for proper inspection of levee slope. No permit has been identified since 2012. (O. Magana - DWR UCIP)08/02/2017 After reviewing record drawings it appears this crossing has remained. This pipe was not part of the Feather River West Levee Improvements, Project D. Pipe is located outside the project limits. Project Improvements began at Station (Sta) 1765+00 (MA0007 about LM 1.73) to Sta 2303+50 (ST0005 about LM 1.23), refer to record drawings for the Feather River West Levee Improvement Plans Station 1765+00 to 2368+26, Project D details. (O. Magana - DWR UCIP)

LS view: pipe visible along LS canal.

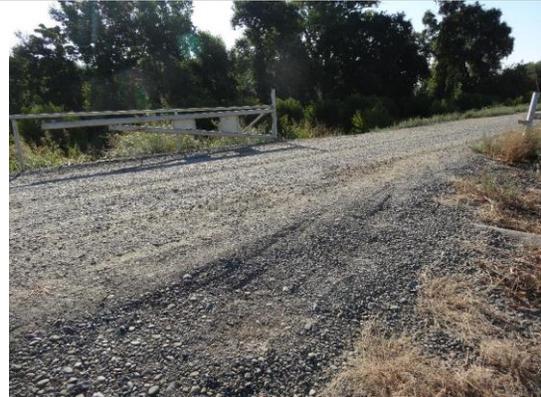
Photo 2 of 3 : UCIP_FA_2020_57380_77331.jpg

Overview of levee crown at crossing looking downstream.

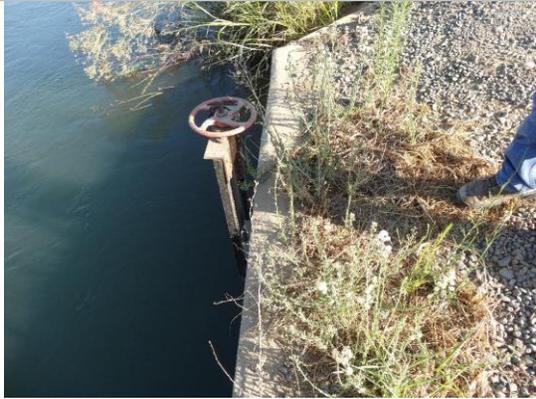
Photo 1 of 3 : UCIP_FA_2020_57381_77335.jpg

DS_ID:16927
 FS_ID:57381
 EP_NO: N/A
 Repair Type: Non-Urgent
 EVAL Issue: Unauthorized Encroachment, installed decades prior
 Crossing Status: Found
 UCIP Comments: 05/07/2019 Record remains Non-Urgent, no permit has been identified for this crossing. Internal inspection has been completed but no pipe evaluation by DMP is available yet. Need to determine if pipe is mainly used for drainage or irrigation. (O. Magana - DWR UCIP)12/07/2018 Encroachment owner information: Sukhraj Singh Pamma, 9850 Sheldon Avenue, Live Oak, CA 95953-9784, 1-530-695-2490. Information obtained from the Levee_Encroachment_listing_11288.pdf which was received from SBFCA. Need to coordinate with CVFPB to determine status of permit. (O. Magana - DWR UCIP)
 08/09/2017 Crossing is still present, unable to confirm is crossing is still in use. Recommend contacting owner to determine status, remove dense vegetation blocking outlet, and to obtain permit authorizing crossing. (O. Magana - DWR UCIP)08/02/2017 After reviewing record drawings it appears this crossing has remained. This pipe was not part of the Feather River West Levee Improvements, Project D. Pipe is located outside the project limits. Project Improvements began at Station (Sta) 1765+00 (MA0007 about LM 1.73) to Sta 2303+50 (ST0005 about LM 1.23), refer to record drawings for the Feather River West Levee Improvement Plans Station 1765+00 to 2368+26, Project D details. (O. Magana - DWR UCIP)

05/16/2016 Feather River West Levee Improvement Project--Levee currently under construction.06/10/2015 WS headwall is still damaged and no repairs were made to this pipe. Looks like the SBFCA project skipped over this area so pipe was not replaced as it was listed to be. (A. Freitag - DWR Sutter Yard)12/29/2014 Same as last inspection. (A. Freitag - DWR Sutter Yard)05/19/2014 Same as last inspection. (A. Freitag - DWR Sutter Yard)11/06/2013 Same as last inspection. (A. Freitag - DWR Sutter Yard)05/13/2013 SBFCA project recommends replacing with accordance to title 23. (A. Freitag - DWR Sutter Yard)05/07/2013 Same as last inspection, however exposed rebar on WS headwall does not impede structure performance. (A. Freitag - DWR Sutter Yard)10/31/2012 WS headwall rebar exposed. This crossing was listed in the USACE Periodic Inspections as ID# USACE_CESPK_MA07_2010_a_0051 however, no issue listed. (O. Magana - DWR UCIP)

LS view: screw gate and concrete headwall visible on LS.

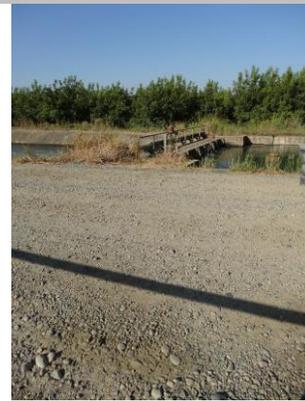
Photo 2 of 3 : UCIP_FA_2020_57381_77336.jpg

Overview of levee crown at crossing.

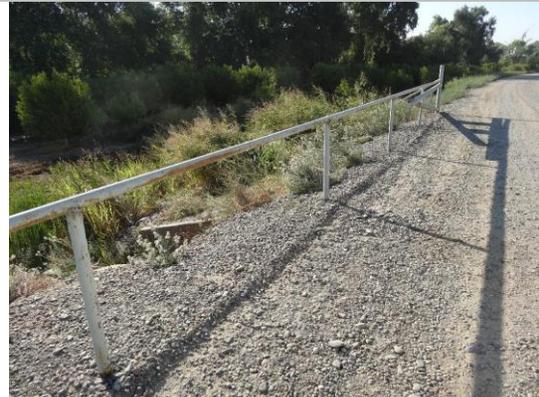
Photo 3 of 3 : UCIP_FA_2020_57381_77337.jpg

WS view: guardrail along the WS slope and concrete headwall visible on WS.

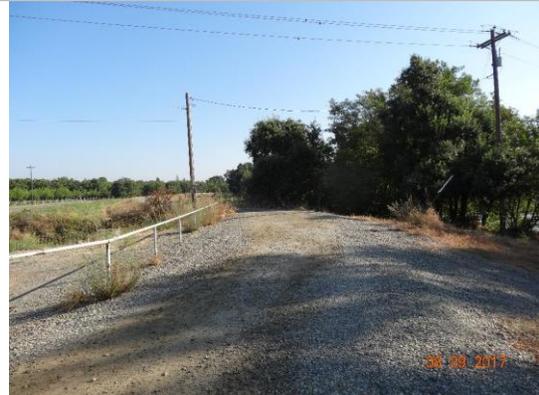
Photo 1 of 3 : UCIP_FA_2020_58358_77346.jpg

05/16/2016 Feather River West Levee Improvement Project--Levee currently under construction. (A. Freitag - DWR Sutter Yard)06/10/2015 Debris still present in risers and pipes were not replaced with the SBFCA project. (A. Freitag - DWR Sutter Yard)12/29/2014 Same as last inspection. (A. Freitag - DWR Sutter Yard)05/19/2014 Same as last inspection. (A. Freitag - DWR Sutter Yard)11/06/2013 Same as last inspection. (A. Freitag - DWR Sutter Yard)05/13/2013 SBFCA project recommends replacing in accordance with title 23. (A. Freitag - DWR Sutter Yard)05/07/2013 Same debris issue as last inspection. Recommend repairing top cover to prevent falls. Wheel to open gate chained and locked so could not verify gate operation. (A. Freitag - DWR Sutter Yard)10/31/2012 Debris inside riser could prevent slide gate from closing. This crossing was listed in the USACE Periodic Inspections as ID#

Overview of levee crown looking upstream towards crossings.

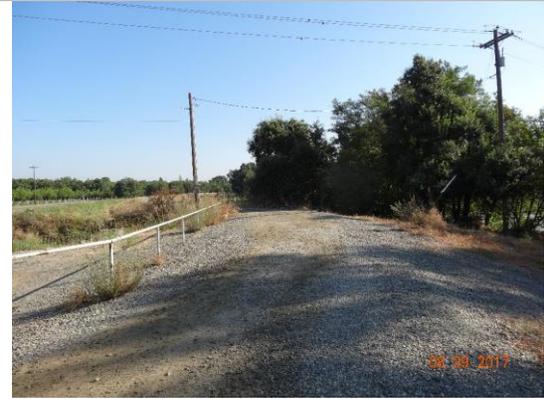
Photo 1 of 3 : UCIP_FA_2020_58359_77352.jpg

05/16/2016 Feather River West Levee Improvement Project--Levee currently under construction. (A. Freitag - DWR Sutter Yard)06/10/2015 Debris still present inside riser and pipe was not replaced with the SBFCA project. (A. Freitag - DWR Sutter Yard)12/29/2014 Same as last inspection. (A. Freitag - DWR Sutter Yard)05/19/2014 Same as last inspection. (A. Freitag - DWR Sutter Yard)11/06/2013 Same as last inspection. (A. Freitag - DWR Sutter Yard)05/13/2013 SBFCA project recommends replacing in accordance with title 23. (A. Freitag - DWR Sutter Yard)05/07/2013 Same as last inspection. Recommend constructing cover to prevent falls. Wheel to operate gate chained and locked so gate operation could not be verified. (A. Freitag - DWR Sutter Yard)10/31/2012 no cover; debris inside riser could prevent slide gate from closing. This crossing was listed in the USACE Periodic Inspections as ID#

Overview of levee crown looking upstream towards crossings.

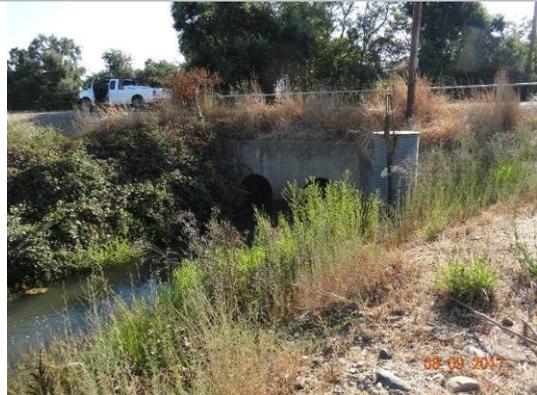
Photo 2 of 3 : UCIP_FA_2020_58359_77357.jpg

LS view: concrete headwall with dual 60-inch crossings.

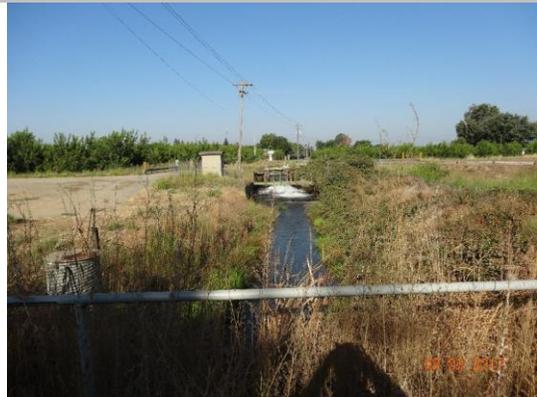
Photo 3 of 3 : UCIP_FA_2020_58359_77358.jpg

LS view: canal located on LS, photo taken from levee crown looking west.

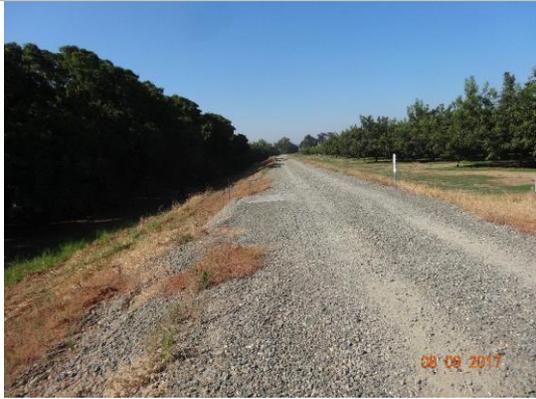
Photo 1 of 3 : UCIP_FA_2020_57387_77133.jpg

DS_ID:20817
 FS_ID:57387
 EP_NO: N/A
 Repair Type: Non-Urgent
 EVAL Issue: Levee Improvement Project
 Crossing Status: Found
 UCIP Comments: 05/07/2019 Record has been updated from No Action Needed to Non-Urgent, no permit has been issued for new pipe. Permit 17213 does not account for improvements made in 2016. Paddle marker is down on the LS slope. (O. Magana - DWR UCIP)08/09/2017 Crossing was field verified and photographed. Photos updated. Permit number and ownership added to description. Owners address Sandra A Waller, 585 Cowee Avenue, Gridley, CA 95948. (O. Magana - DWR UCIP)08/02/2017 Crossing was rehabilitated under the Feather River West Levee Improvements, Project D. Project Improvements begin at Station (Sta) 1765+00 (MA0007 about LM 1.73) to Sta 2303+50 (ST0005 about LM 1.23), refer to record drawings for the Feather River West Levee Improvement Plans Station 1765+00 to 2368+26, Project D details. MA0007 project details include NO CUTOFF WALL from Sta 1765+00 (MA0007 about LM 1.73) to 1815+00 (MA0007 about LM 2.64) and LEVEE DEGRADE AND RECONSTRUCTION WITH CUT OFF WALL from Sta 1817+00 (MA0007 about LM 2.69) to Sta 2289+00, Sta 2287+00 to Sta 2290+00 (MA0007 about LM 11.60). (O. Magana - DWR UCIP) 5/16/2016 Feather River West Levee Improvement Project--Levee currently under construction. New gate valve, referenced as STA 1799+44, will be installed as indicated in the project Plans for Construction of Feather River West Levee Project, Project Area A, Feather River West Levee Improvement Plans, Sta 1765+00 to 2368+26, Volume 3 of 5. (O. Magana - DWR UCIP)06/10/2015 Air vac is still bent over. (A. Freitag - DWR Sutter Yard)12/29/2014 Same as last inspection. (A. Freitag - DWR Sutter Yard)05/19/2014 Same as last inspection. (A. Freitag - DWR Sutter Yard)11/06/2013 Air vac bent over and both metal posts are laying at toe of levee. (A. Freitag - DWR Sutter Yard)05/13/2013 Permit number and owner in detailed report book. (A. Freitag - DWR Sutter Yard)05/07/2013 Need to find owner of structure. (A. Freitag - DWR Sutter Yard)10/30/2012 Need permit authorizing work. (O. Magana - DWR UCIP) FIELD_STRUCT_DESC: 8-inch irrigation siphon pipe of an unknown material, 2.3 feet below the crown. Air release valve on the waterside (WS) shoulder protected by two metal bollards. (Existing 8-inch pressurized pipe crossing protected in place. 2 feet of the pipe on the landside (LS) of the gate valve removed and replaced with 8-inch inside diameter pressurized pipe of an unknown material. Existing air release valve and two metal bollards removed and disposed. Existing valve opening plugged. Two 8-inch C509 standard FL by FL Mueller A-2360 resilient wedge or approved equal gate valves installed, one on the WS

Overview of levee crown looking downstream

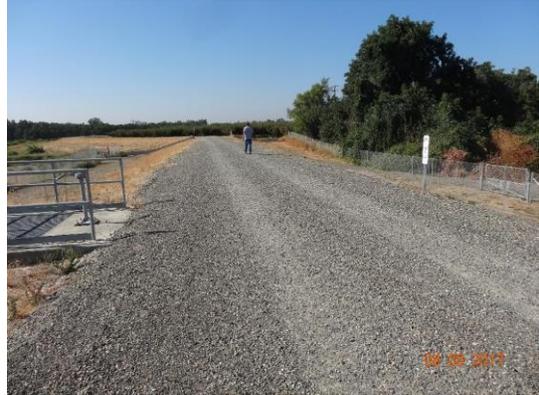
Photo 2 of 3 : UCIP_FA_2020_57389_77188.jpg

Overview of levee crown looking downstream

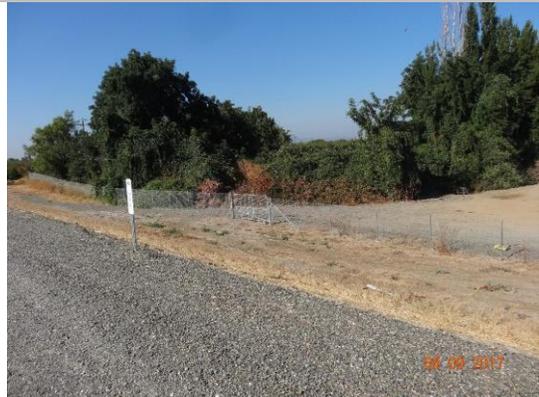
Photo 3 of 3 : UCIP_FA_2020_57389_77189.jpg

Overview of LS

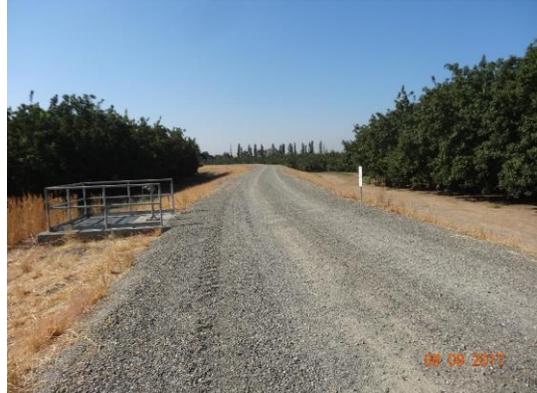
Photo 2 of 3 : UCIP_FA_2020_57390_77179.jpg

Overview of levee crown looking downstream at crossing.

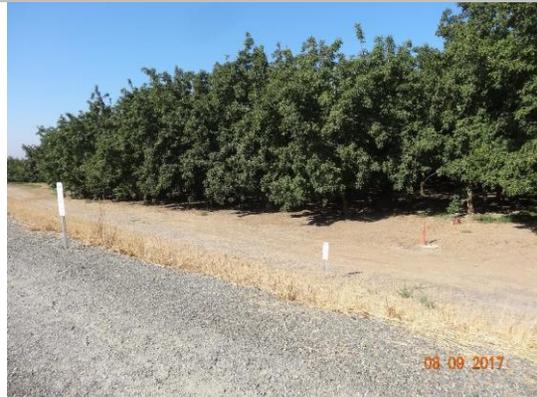
Photo 3 of 3 : UCIP_FA_2020_57390_77180.jpg

Overview of LS looking downstream at crossing.

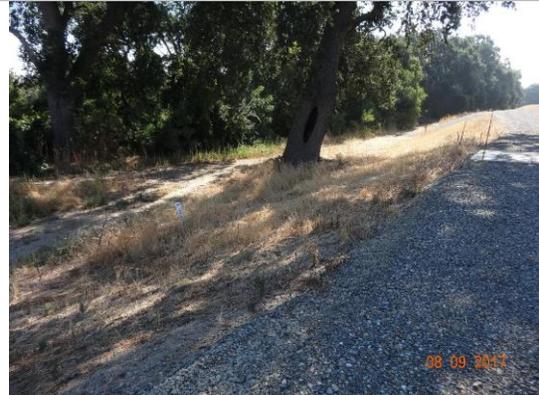
Photo 1 of 3 : UCIP_FA_2020_57391_77194.jpg

Overview of WS looking downstream at crossing.

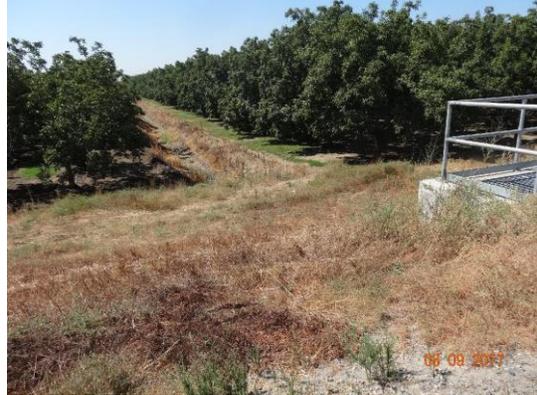
Photo 2 of 3 : UCIP_FA_2020_58342_77219.jpg

LM Start	5.38	Rating **	M	Issue No.	85 (cont)
LM End	5.38	Issue Type +	En	Location *	
Category	Supplemental			GPS Latitude/Longitude	
				Start	End
Item	DWR UCIP Field Study			39.380377 °	39.380377 °
				-121.649344 °	-121.649344 °
DWR ID	25512

Overview of WS

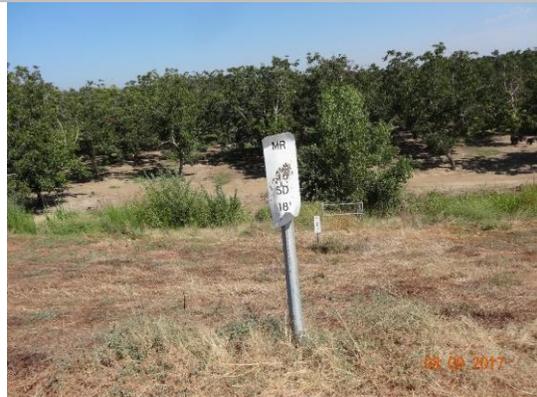
Photo 3 of 3 : UCIP_FA_2020_58342_77220.jpg

Overview of LS

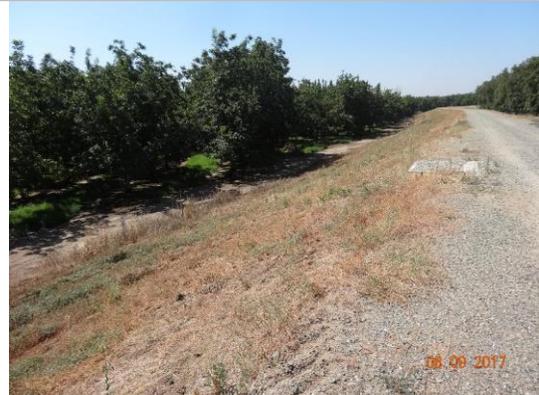
Photo 1 of 3 : UCIP_FA_2020_58344_77246.jpg

DS_ID:25513
 FS_ID:58344
 EP_NO: 4591
 Repair Type: Non-Urgent
 EVAL Issue: Levee Improvement Project
 Crossing Status: Found
 UCIP Comments: 05/07/2019 Record has been updated from No Action Needed to Non-Urgent, no permit has been issued by the CVFPB. Recommend auditing Permit No. 4591 to determine if modifications made under the levee improvement project are assumed under current permit or if new permit will be issued. No other issues were recorded during inspection. (O. Magana - DWR UCIP)08/09/2017 Crossing was visited and field verified. Coordinates updated to show pipes new location (39.38342, -121.63595). CLM will need to be updated also. Photos added. (A. Freitag - DWR Sutter Yard)08/08/2017 Crossing was installed under the Feather River West Levee Improvements, Project D. Project Improvements begin at Station (Sta) 1765+00 (MA0007 about LM 1.73) to Sta 2303+50 (ST0005 about LM 1.23), refer to record drawings for the Feather River West Levee Improvement Plans Station 1765+00 to 2368+26, Project D details. MA0007 project details include NO CUTOFF WALL from Sta 1765+00 (MA0007 about LM 1.73) to 1815+00 (MA0007 about LM 2.64) and LEVEE DEGRADE AND RECONSTRUCTION WITH CUT OFF WALL from Sta 1817+00 (MA0007 about LM 2.69) to Sta 2289+00, Sta 2287+00 to Sta 2290+00 (MA0007 about LM 11.60). (O. Magana - DWR UCIP)

Overview of WS

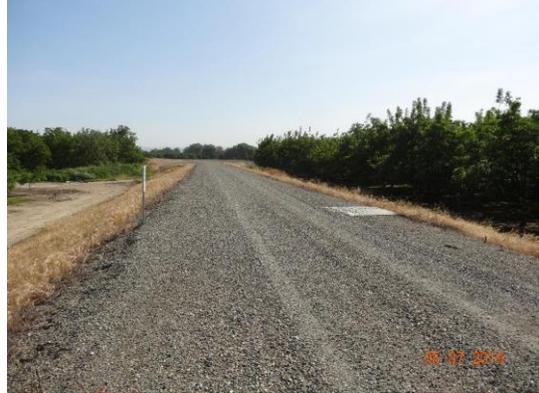
Photo 1 of 3 : UCIP_FA_2020_58345_80697.jpg

Comment Code					
Inspector Comment					
<p>DS_ID:25526 FS_ID:58345 EP_NO: N/A Repair Type: Non-Urgent EVAL Issue: Levee Improvement Project Crossing Status: Found UCIP Comments: 05/07/2019 Record has been updated from No Action Needed to Non-Urgent, no permit has been issued by the CVFPB. No other issues were recorded during inspection. (O. Magana - DWR UCIP)07/09/2018 As-built drawings show work deleted however, field visit shows pipe was installed. No permit has been identified for this crossing. (O. Magana - DWR UCIP) 08/08/2017 Crossing was installed under the Feather River West Levee Improvements, Project D. Project Improvements begin at Station (Sta) 1765+00 (MA0007 about LM 1.73) to Sta 2303+50 (ST0005 about LM 1.23), refer to record drawings for the Feather River West Levee Improvement Plans Station 1765+00 to 2368+26, Project D details. MA0007 project details include NO CUTOFF WALL from Sta 1765+00 (MA0007 about LM 1.73) to 1815+00 (MA0007 about LM 2.64) and LEEVE DEGRADE AND RECONSTRUCTION WITH CUT OFF WALL from Sta 1817+00 (MA0007 about LM 2.69) to Sta 2289+00, Sta 2287+00 to Sta 2290+00 (MA0007 about LM 11.60). (O. Magana - DWR UCIP) FIELD_STRUCT_DESC: 12-inch pressurized steel (assumed) irrigation pipe through the levee, 2.8 feet below the levee crown. 12-inch C509 FL by FL gate valve, Mueller A-2360 Resilient Wedge or an approved equal, on the waterside (WS) shoulder. Utility box with cover houses a combination siphon breaker and air relief valve located on the WS. (Existing 22-inch steel pipe was removed and replaced with a new 12-inch steel pressure irrigation pipe during the Feather River West Levee Improvements, Project D). [Additional Reference(s): Sutter Butte Flood Control Agency (SBFCA) Feather River West Levee Project, Volume 4 of 6 (Project D) Feather River West Levee Improvement Plans Sta 1765+00 to 2368+26, 2016, Volume 4-SBFCA_Record_Drawings_Project D_2017.05.16.pdf, Drawing No. C-535, STA 2017+70] FS Date: 5/7/2019 12:39:00 PM</p>

Overview of levee crown looking u/s towards crossing.

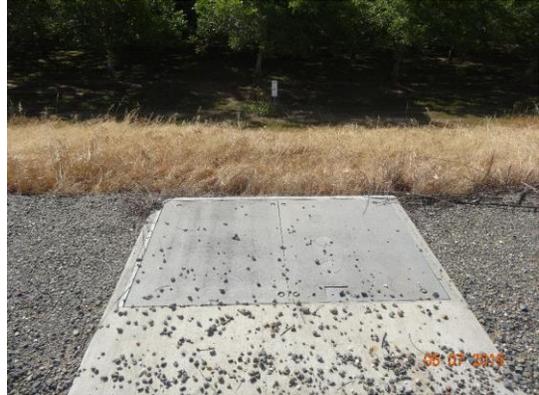
Photo 2 of 3 : UCIP_FA_2020_58345_80698.jpg

WS view: concrete vault with cover and paddle marker visible on WS pipe alignment.

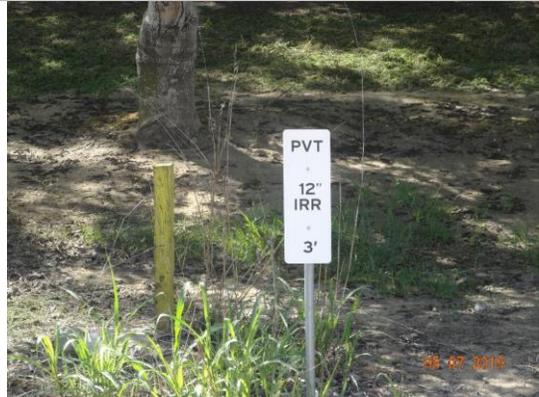
Photo 3 of 3 : UCIP_FA_2020_58345_80699.jpg

WS view: close up view of paddle marker located on WS toe.

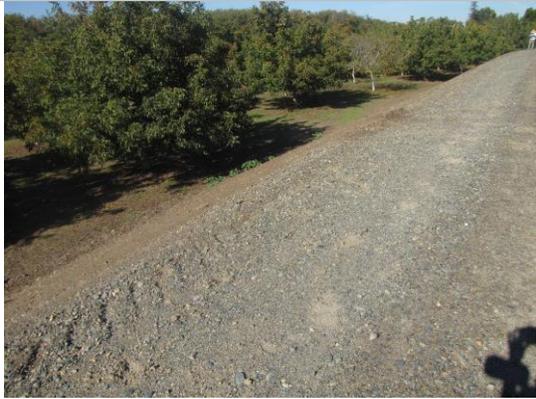
Photo 1 of 3 : UCIP_FA_2020_58443_65923.jpg

DS_ID:16960
 FS_ID:58443
 EP_NO: 17895
 Repair Type: Non-Urgent
 EVAL Issue: Pipe Not Found
 Crossing Status: Not Found
 UCIP Comments: 05/07/2019 Record has been updated from No Action Needed to Non-Urgent, no pipe was found during inspection. Photos taken to show that there is no evidence of 5-inch line. Need to coordinate with CVFPB to find out if pipe permit was withdrawn. (O. Magana - DWR UCIP)08/09/2017 Field confirmed no signs of crossing at this location, levee section removed and rebuilt with slurry wall. No photos were taken at this location. Recommend taking photos of current condition at this site and append to this record. (O. Magana - DWR UCIP)08/08/2017 Pre-construction drawings, for construction drawings, show this crossing removed and replaced, however record drawings (post-construction) do not reference this crossing. Need to follow up with consultants responsible for record drawings to determine status of this crossing -- conflicting information between pre- and post-construction drawings. Project Improvements begin at Station (Sta) 1765+00 (MA0007 about LM 1.73) to Sta 2303+50 (ST0005 about LM 1.23), refer to record drawings for the Feather River West Levee Improvement Plans Station 1765+00 to 2368+26, Project D details. MA0007 project details include NO CUTOFF WALL from Sta 1765+00 (MA0007 about LM 1.73) to 1815+00 (MA0007 about LM 2.64) and LEVEE DEGRADE AND RECONSTRUCTION WITH CUT OFF WALL from Sta 1817+00 (MA0007 about LM 2.69) to Sta 2289+00, Sta 2287+00 to Sta 2290+00 (MA0007 about LM 11.60). (O. Magana - DWR UCIP) 05/16/2016 Feather River West Levee Improvement Project--Levee currently under construction. Crossing, referenced as STA 2084+03, will be removed and replaced as indicated in the project Plans for Construction of Feather River West Levee Project, Project Area A, Feather River West Levee Improvement Plans, Sta 1765+00 to 2368+26, Volume 3 of 5. (A. Freitag - DWR Sutter Yard)06/10/2015 Minor erosion still present near air vent. (A. Freitag - DWR Sutter Yard)12/30/2014 Same as last inspection. (A. Freitag - DWR Sutter Yard)05/19/2014 Same as last inspection. (A. Freitag - DWR Sutter Yard)11/07/2013 Same as last inspection. (A. Freitag - DWR Sutter Yard)11/05/2012 localized erosion at air vent located on WS shoulder; this crossing appears to have leaking at the air vent--will need to determine reason for erosion at air vent (vehicles going over vent?); also recommend installing utility marker. (O. Magana - DWR UCIP) FIELD_STRUCT_DESC: *UNCLEAR status* 5-inch steel irrigation pipe through the levee, at an unknown depth. Pipe connects to an existing pipe within the overflow area of the Feather River. (5-inch irrigation line authorized under Permit No. 17895, 2005 - John Kucek. 0.75-inch

View of LS and levee crown looking upstream towards crossing.

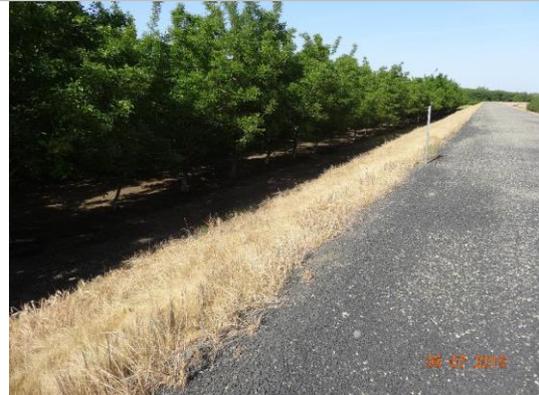
Photo 1 of 3 : UCIP_FA_2020_58394_80707.jpg

Comment Code					
Inspector Comment					
DS_ID:25527 FS_ID:58394 EP_NO: N/A Repair Type: Non-Urgent EVAL Issue: Levee Improvement Project Crossing Status: Found UCIP Comments: 05/07/2019 Record has been updated from No Action Needed to Non-Urgent, no permit has been issued by the CVFPB authorizing pipe. No other issues were recorded during inspection. (O. Magana - DWR UCIP) FIELD_STRUCT_DESC: 2-inch pressurized pipe of an unknown material or purpose through the levee, 3 feet below the crown. [Additional Reference(s): Sutter Butte Flood Control Agency (SBFCA) Feather River West Levee Project, Volume 4 of 6 (Project D) Feather River West Levee Improvement Plans Sta 1765+00 to 2368+26, 2016, Volume 4-SBFCA_Record_Drawings_Project D_2017.05.16.pdf, Drawing No. C-137 and C-543]. FS Date: 5/7/2019

LS view: overview of LS.

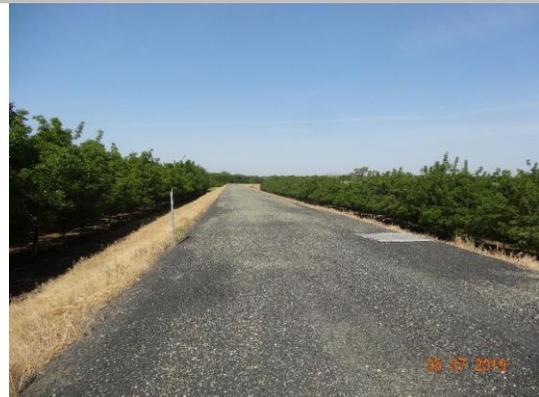
Photo 2 of 3 : UCIP_FA_2020_58394_80708.jpg

Overview of levee crown looking u/s towards pipe crossing.

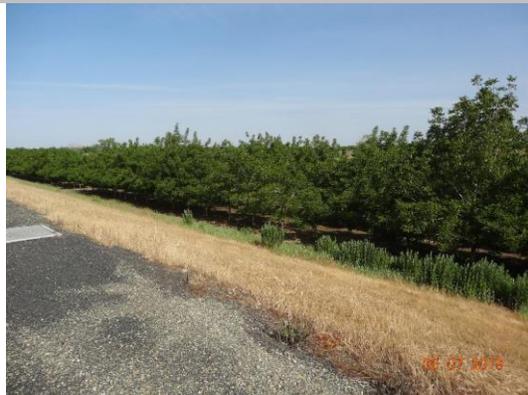
Photo 3 of 3 : UCIP_FA_2020_58394_80709.jpg

WS view: overview of WS.

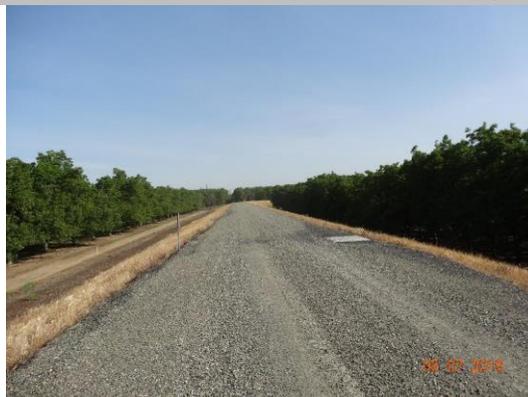
Photo 1 of 3 : UCIP_FA_2020_55084_80715.jpg

Overview of levee crown looking u/s towards pipe crossing.

Comment Code					
Inspector Comment					
DS_ID:25528 FS_ID:55084 EP_NO: N/A Repair Type: Non-Urgent EVAL Issue: Levee Improvement Project Crossing Status: Found UCIP Comments: 05/07/2019 Record has been updated from No Action Needed to Non-Urgent, no permit has been issued by the CVFPB authorizing pipe. No other issues were recorded during inspection. (O. Magana - DWR UCIP) FIELD_STRUCT_DESC: 2-inch steel irrigation pipe through the levee, 3 feet below the levee crown. Concrete vault located at the waterside (WS) shoulder. (2-inch irrigation line installed under the Feather River Levee Improvement Project; Existing 2-inch irrigation pipe crossing removed and disposed portion within construction limit during the Feather River West Levee Improvements, Project D authorized under Permit No. 18793-3, 2014 - Sutter Butte Flood Control Agency). [Additional Reference(s): Sutter Butte Flood Control Agency (SBFCA) Feather River West Levee Project, Volume 4 of 6 (Project D) Feather River West Levee Improvement Plans Sta 1765+00 to 2368+26, 2016, Volume 4-SBFCA_Record_Drawings_Project_D_2017.05.16.pdf, Drawing No. C-545]. FS Date: 5/7/2019

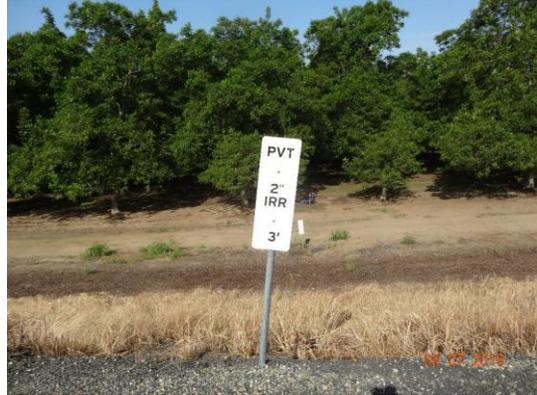
Photo 2 of 3 : UCIP_FA_2020_55084_80716.jpg

LS view: paddle marker along pipe alignment.

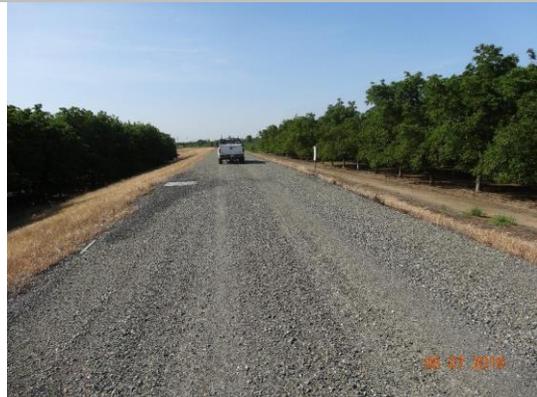
Photo 3 of 3 : UCIP_FA_2020_55084_80717.jpg

Overview of levee crown looking d/s towards pipe crossing.

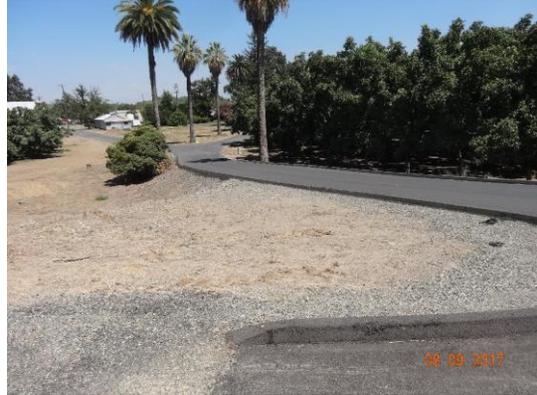
Photo 1 of 3 : UCIP_FA_2020_57400_77245.jpg

Comment Code					
Inspector Comment					
<p>DS_ID:25515 FS_ID:57400 EP_NO: N/A Repair Type: Non-Urgent EVAL Issue: Levee Improvement Project Crossing Status: Found UCIP Comments: 05/07/2019 Record has been updated from No Action Needed to Non-Urgent, no permit has been issued by the CVFPB authorizing pipe. Unable to confirm if pipe was installed during the Feather River West Levee Improvement Plans. No other issues were recorded during inspection. (O. Magana - DWR UCIP)08/09/2017 No evidence was found of crossing through the levee. The only indicator of a potential telephone crossing is from a riser that is located about 200-feet from WS shoulder, see photos. Feather River West Levee Improvements, Project D, Drawing No. C-151 indicates conduit was installed--depth unknown. No permit is currently available. Need to coordinate with CVFPB regarding the permits issued for the crossings authorized under Feather River West Levee Improvements project. (O. Magana - DWR UCIP)08/08/2017 Crossing was installed under the Feather River West Levee Improvements, Project D. Project Improvements begin at Station (Sta) 1765+00 (MA0007 about LM 1.73) to Sta 2303+50 (ST0005 about LM 1.23), refer to record drawings for the Feather River West Levee Improvement Plans Station 1765+00 to 2368+26, Project D details. MA0007 project details include NO CUTOFF WALL from Sta 1765+00 (MA0007 about LM 1.73) to 1815+00 (MA0007 about LM 2.64) and LEVEE DEGRADE AND RECONSTRUCTION WITH CUT OFF WALL from Sta 1817+00 (MA0007 about LM 2.69) to Sta 2289+00, Sta 2287+00 to Sta 2290+00 (MA0007 about LM 11.60). (O. Magana - DWR UCIP) FIELD_STRUCT_DESC: Telephone conduit of an unknown size or material through the levee, at an unknown depth. (Existing 0.75-inch telephone conduit crossing removed and replaced portion within construction limit with a new telephone conduit crossing). [Additional Reference(s): Sutter Butte Flood Control Agency (SBFCA) Feather River West Levee Project, Volume 4 of 6 (Project D) Feather River West Levee Improvement Plans Sta 1765+00 to 2368+26, 2016, Volume 4-SBFCA_Record_Drawings_Project D_2017.05.16.pdf, Drawing No. C-151]. FS Date: 5/7/2019 12:48:00 PM</p>

WS view: overview of WS, riser visible off paved road near palm trees.

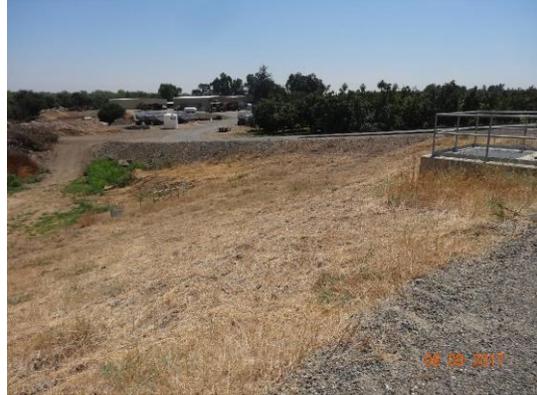
Photo 2 of 3 : UCIP_FA_2020_57401_77243.jpg

Overview of WS slope at crossing.

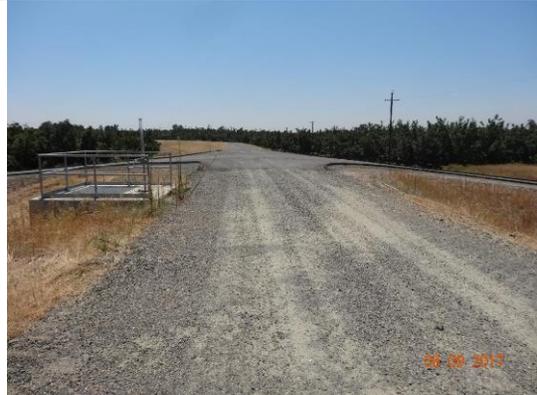
Photo 3 of 3 : UCIP_FA_2020_57401_77234.jpg

Overview of levee crown looking downstream at crossing.

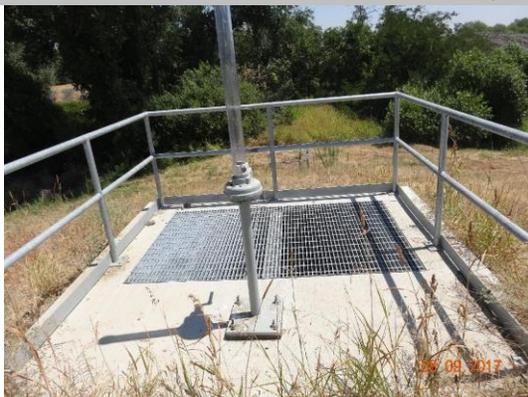
Photo 2 of 3 : UCIP_FA_2020_57402_77208.jpg

WS view: gate riser structure located on WS shoulder.
