Engineer's Report

Feather River West Levee Phase I ULDC
Compliance

Station 512+00 to 1674+37 and Station 1769+31
to 2368+26

Sutter Butte Flood Control Agency

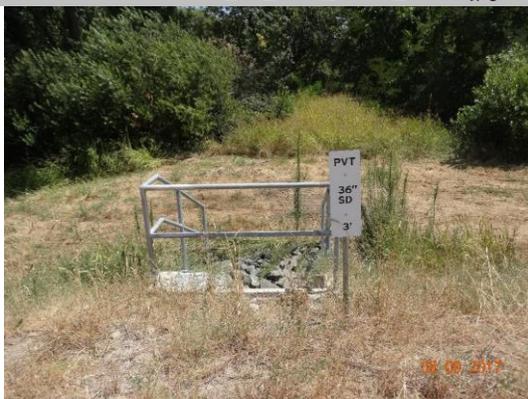
Photo 3 of 3 : UCIP_FA_2020_57402_77212.jpg

WS view: paddle marker visible just above concrete headwall with guard rails.

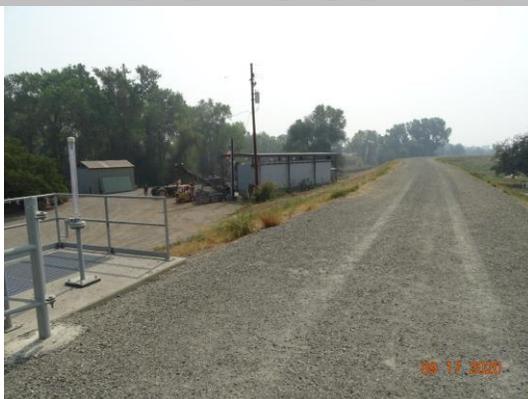
Photo 1 of 1 : FA_2020_MA0007_200_40_20200929_00079.jpg

LM Start	11.49	Rating **	M	Issue No.	40
LM End	11.49	Issue Type +	En	Location *	WS
Category	Earthen Levee			GPS Latitude/Longitude	
				Start	End
Item	Encroachments			39.437454 °	39.437454 °
				-121.646024 °	-121.646024 °
DWR ID	DWR_MA0007_01_s_2016_40				
Comment Code					
BU : Building					
Inspector Comment					
No permit was found for this structure.

View showing structure on the waterside looking downstream.

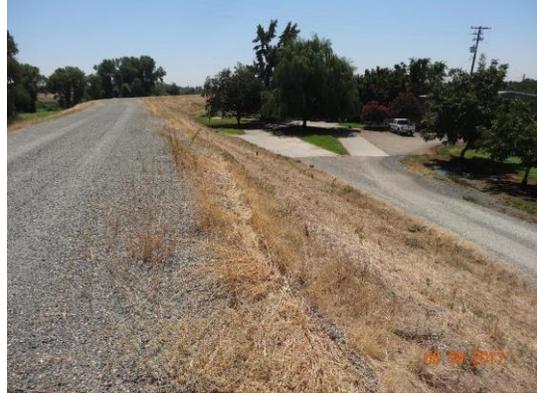
Photo 2 of 3 : UCIP_FA_2020_57403_77204.jpg

Overview of levee crown and LS slope, looking downstream from crossing.

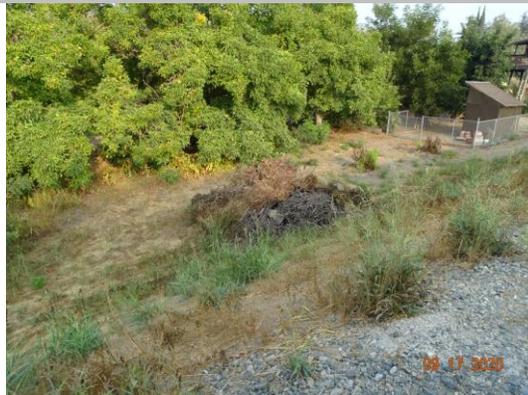
Photo 1 of 1 : FA_2020_MA0016_302_9_20200929_00011.jpg

LM Start	0.14	Rating **	M	Issue No.	9
LM End	0.14	Issue Type +	En	Location *	LS
Category	Earthen Levee		GPS Latitude/Longitude		
			Start	End	
Item	Encroachments		39.257832 °	39.257832 °	
			-121.636640 °	-121.636640 °	
DWR ID	DWR_MA0016_01_f_2020_9				
Comment Code					
DE : Debris					
Inspector Comment					
Debris pile against levee toe should be removed, Fall 2020

View of debris pile on landside levee toe, Fall 2020.

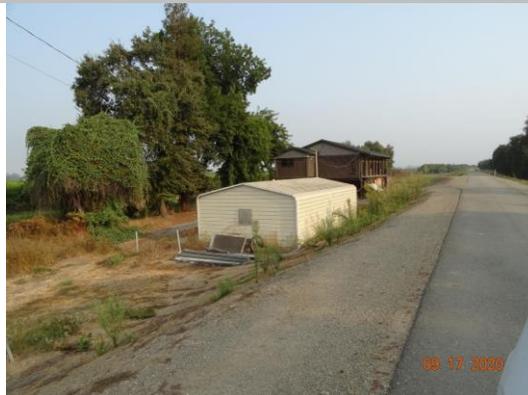
Photo 1 of 1 : FA_2020_MA0016_302_10_20200929_00012.jpg

LM Start	0.43	Rating **	M	Issue No.	10
LM End	0.43	Issue Type +	En	Location *	LS
Category	Earthen Levee		GPS Latitude/Longitude		
			Start	End	
Item	Encroachments		39.262054 °	39.262054 °	
			-121.636609 °	-121.636609 °	
DWR ID	DWR_MA0016_01_f_2020_10				
Comment Code					
BU : Building					
Inspector Comment					
Unpermitted building located on the landside levee toe should be removed, Fall 2020.

View of building on landside levee toe, Fall 2020

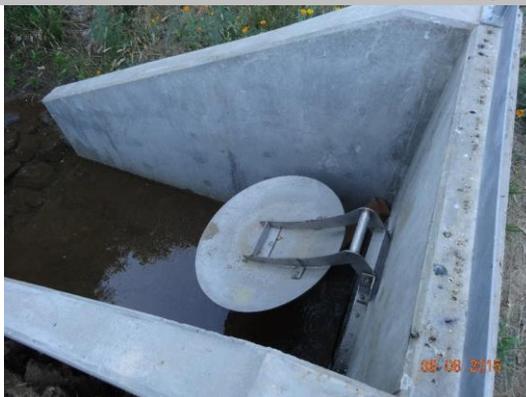
Photo 2 of 3 : UCIP_FA_2020_57714_75283.jpg

WS concrete headwall and flap gate.

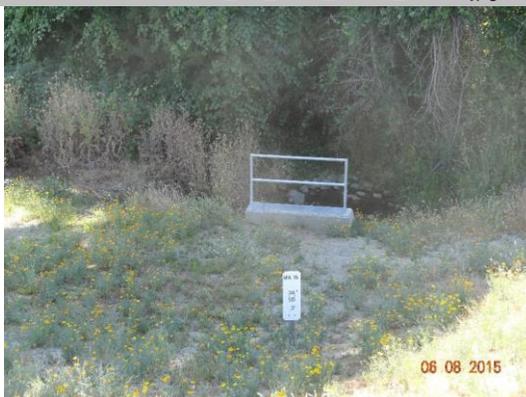
Photo 3 of 3 : UCIP_FA_2020_57714_75284.jpg

WS view photo taken from levee crown looking at WS slope.

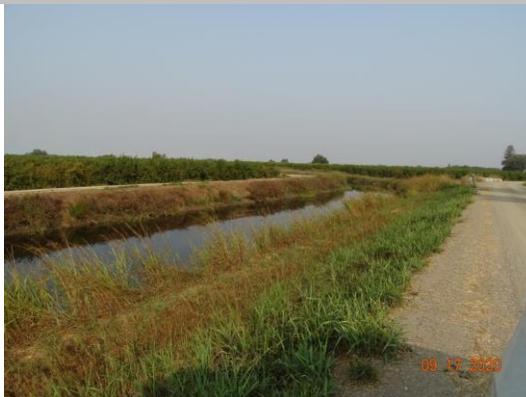
Photo 1 of 1 : FA_2020_MA0016_302_14_20200929_00016.jpg

LM Start	2.85	Rating **	M	Issue No.	14
LM End	3.08	Issue Type +	En	Location *	LS
Category	Earthen Levee			GPS Latitude/Longitude	
				Start	End
Item	Encroachments			39.293675 °	39.296748 °
				-121.636615 °	-121.638192 °
DWR ID	DWR_MA0016_01_s_2012_14				
Comment Code					
DT : Ditch					
Inspector Comment					
An agricultural ditch is located at the landside slope and toe.

View of agricultural ditch at the landside slope and toe.

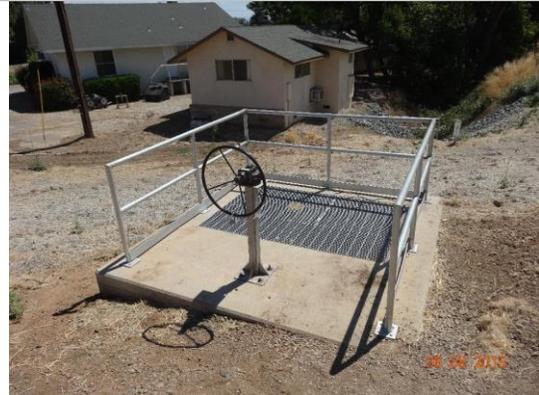
Photo 1 of 3 : UCIP_FA_2020_57712_75286.jpg

DS_ID:25458
 FS_ID:57712
 EP_NO: N/A
 Repair Type: Non-Urgent
 EVAL Issue: Levee Improvement Project
 Crossing Status: Found
 UCIP Comments: 05/22/2019 Record has been updated from No Action Needed to Non-Urgent, no permit has been issued by the CVFPB authorizing this pipe. (O. Magana - DWR UCIP)05/22/2017 Crossing appears to be in good condition. Pipe has been selected to be internally cleaned and inspected as part of the DMP project. (A. Freitag - DWR Sutter Yard)12/01/2016 Crossing appears to be in good condition. (A. Freitag - DWR Sutter Yard)06/21/2016 Inspector's notes and photos related to new pipe from DS_ID 17175 have been transferred. Pipe record (DS_ID 17175) has been retired since pipe was removed from the levee and a new pipe was installed. (O. Magana - DWR UCIP)05/26/2016 Crossing appears to be in good condition. (A. Freitag - DWR Sutter Yard)06/08/2015 Pipe has been replaced with the completion of the SBFCA project in this area. Pipe is now a 36-inch corrugated metal pipe. New headwall and flap gate located at WS toe with a new positive closure structure on WS shoulder. LS inlet was replaced and pipe markers to show the location and depth are located all along the pipe alignment. (A. Freitag - DWR Sutter Yard)

WS view of positive closure structure.

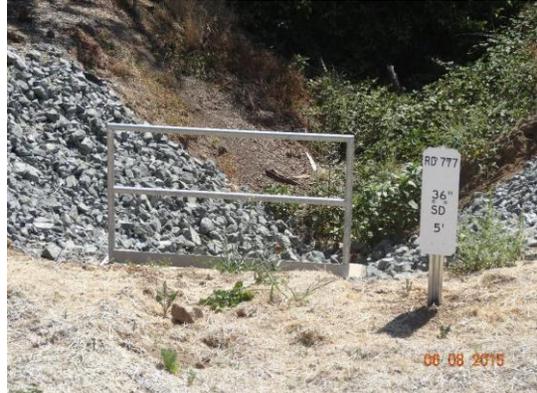
Photo 2 of 3 : UCIP_FA_2020_57712_75287.jpg

WS view of guardrail attached to concrete headwall. Marker located on WS.

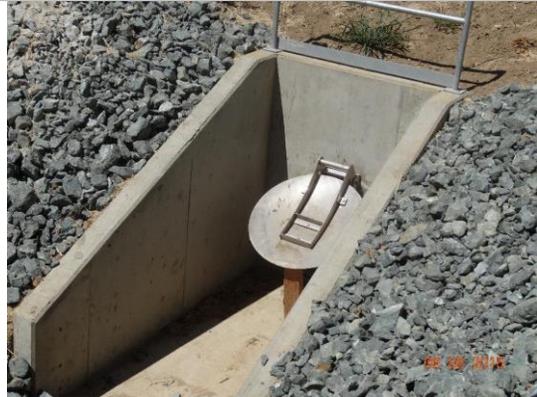
Photo 3 of 3 : UCIP_FA_2020_57712_75288.jpg

WS view of headwall and flap gate.

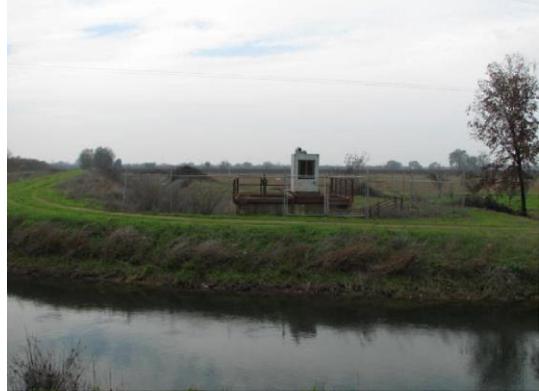
Photo 2 of 3 : UCIP_FA_2020_58700_65784.jpg

Pumping plant and slide gate on LS across canal. (no access from levee).

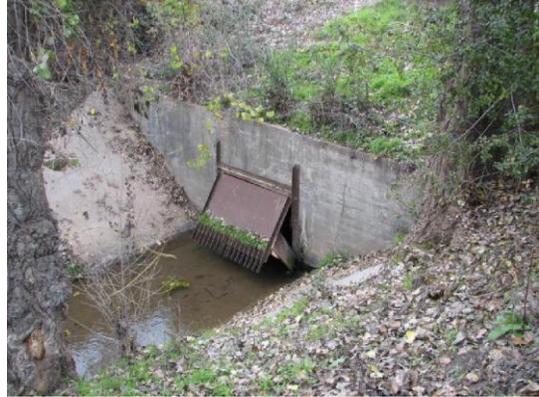
Photo 3 of 3 : UCIP_FA_2020_58700_65783.jpg

Concrete headwall and flap gate on WS toe.
